## Operational Inspection

Tarporley Parish Council

Tarporley Community Centre

Operational Inspection - 8-February-2019 - 08:31 Inspector John-Aris Hirst (RPII Annual Inspector)

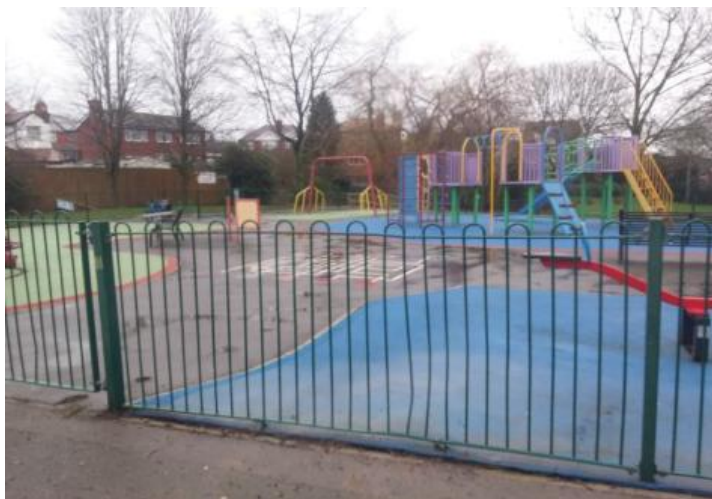
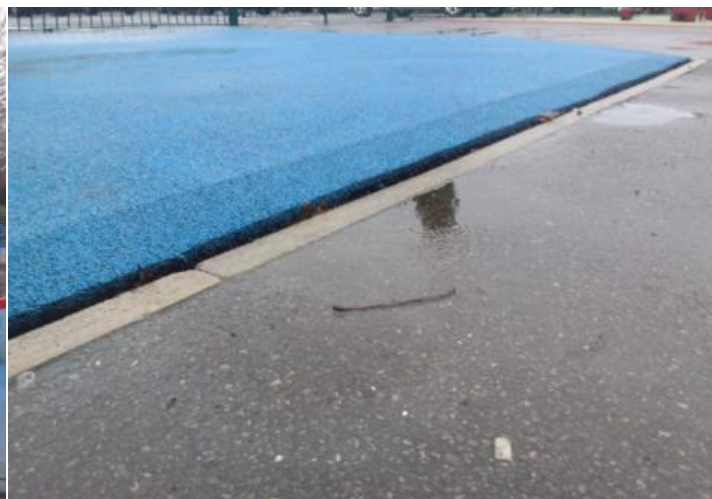
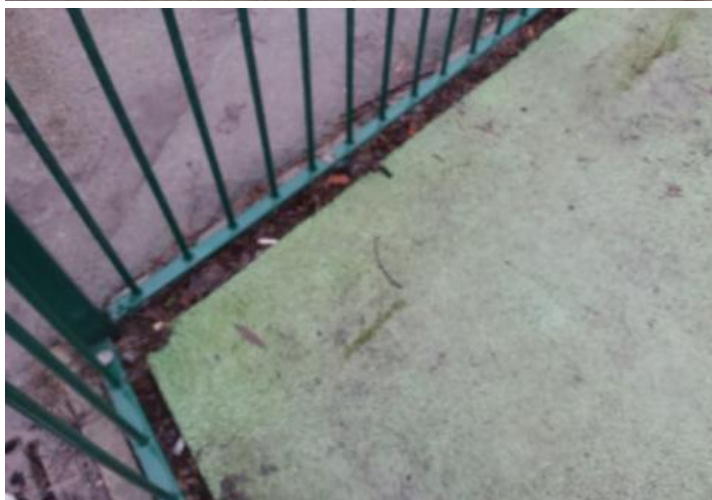
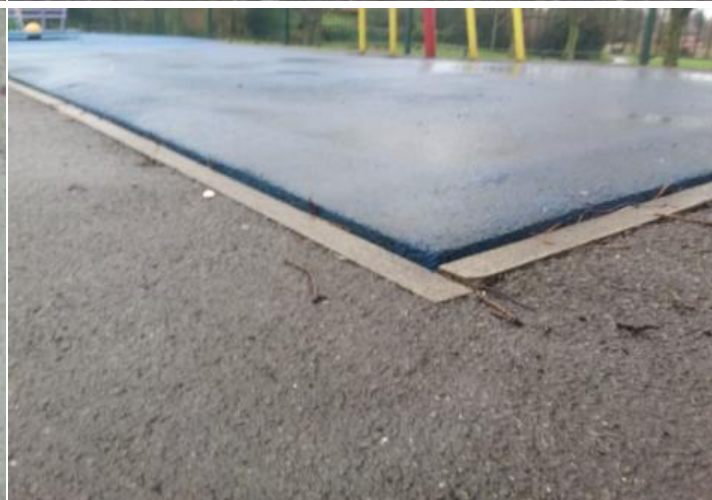
The surface is lifting at the edges and creating trip points - Repair perimeter of surfacing to remove trip points

**Finding:** The surface is lifting at the edges and creating trip points

**Action:** Repair perimeter of surfacing to remove trip points

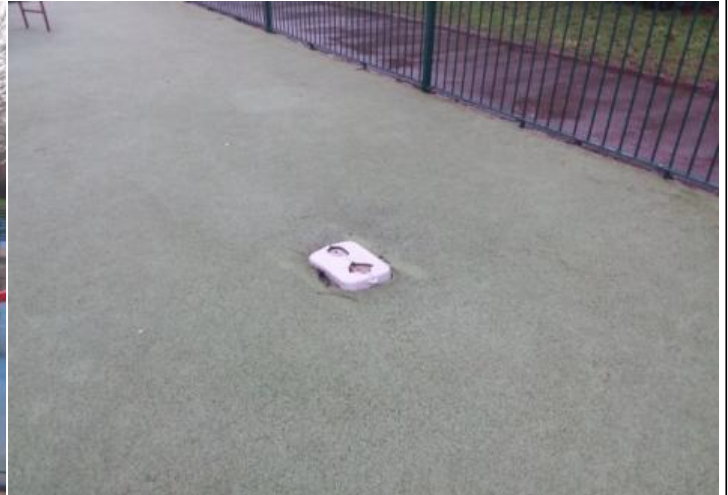
There is a redundant spring base present - Replace the missing springer or remove the base and repair the surface

**Finding:** There is a redundant spring base present

**Action:** Replace the missing springer or remove the base and repair the surface

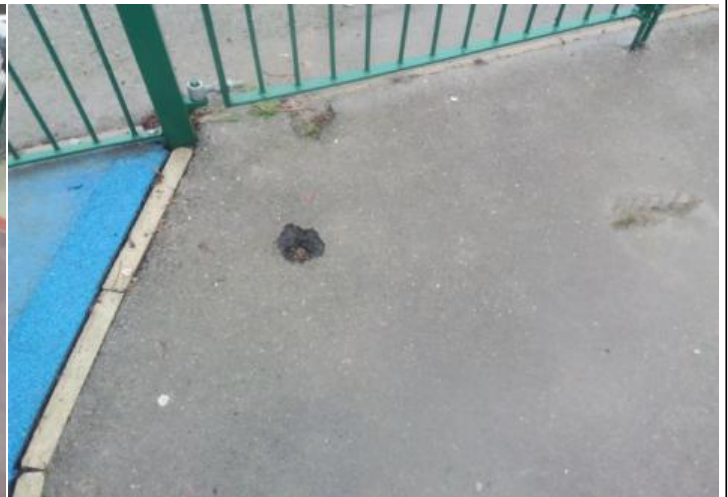
The bitumen surface is worn or damaged - Repair the bitumen to provide a uniform surface

**Finding:** The bitumen surface is worn or damaged

**Action:** Repair the bitumen to provide a uniform surface

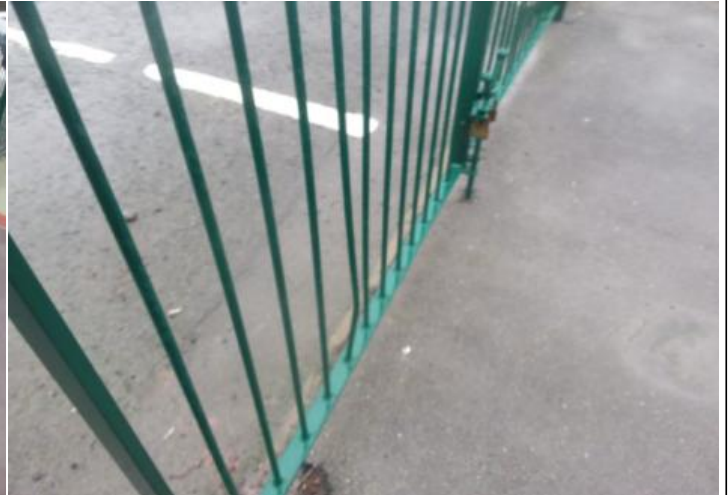
There is some damage to the infill bars - Repair or replace as required

**Finding:** There is some damage to the infill bars

**Action:** Repair or replace as required

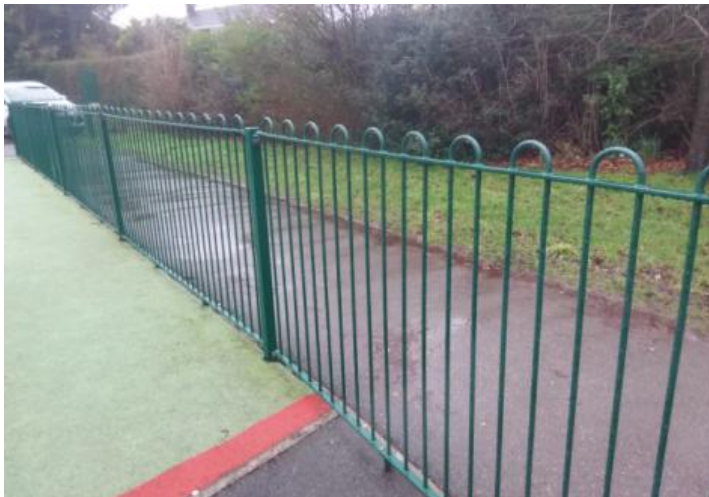
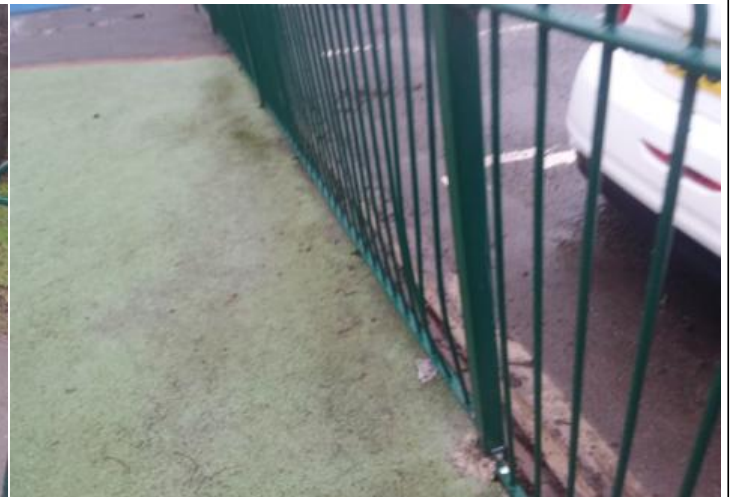
There is some damage to the fence sections - Monitor for any further deterioration and repair as required

**Finding:** There is some damage to the fence sections

**Action:** Monitor for any further deterioration and repair as required

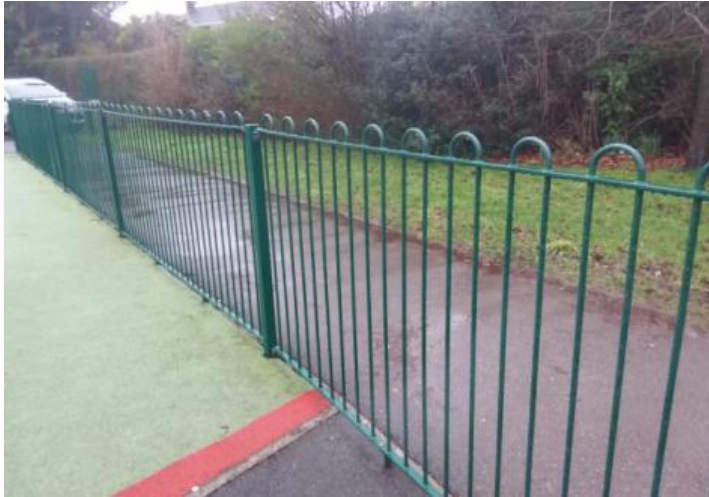
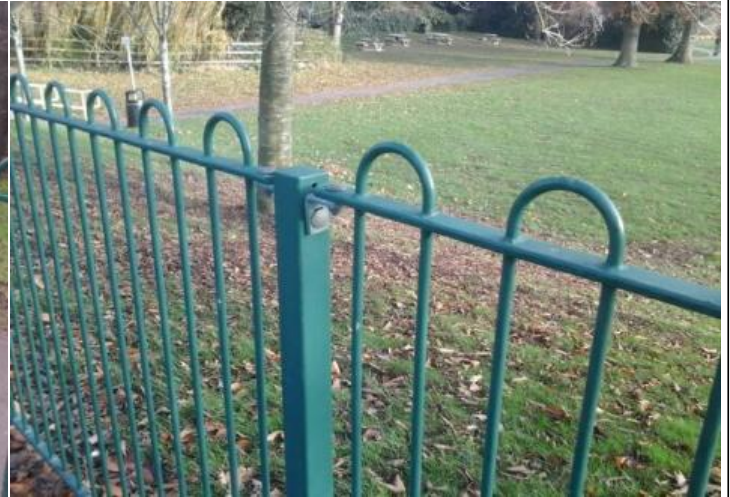
A number of fixings have worked loose around the fencing - Secure all loose fixings

**Finding:** A number of fixings have worked loose around the fencing  
**Action:** Secure all loose fixings

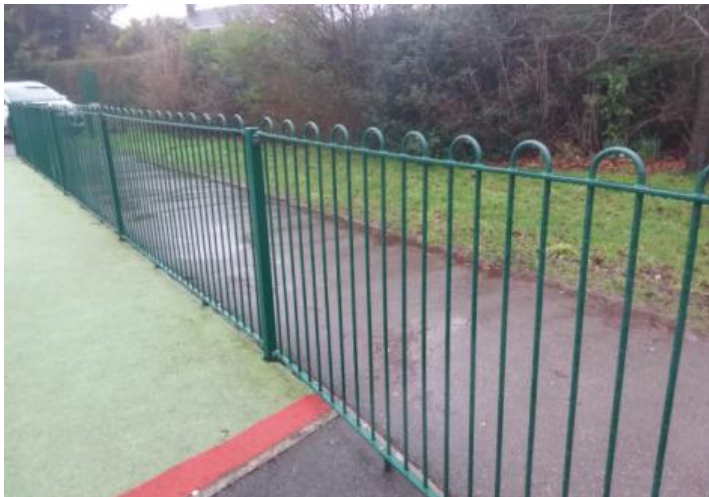
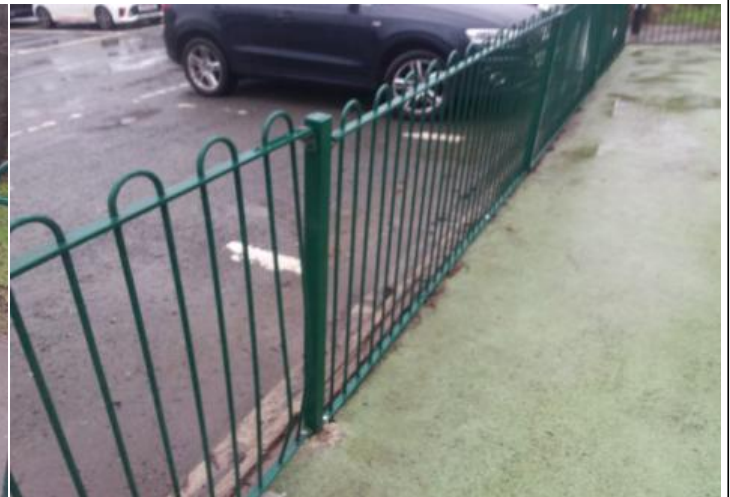
There are a number of loose posts around the fence - Monitor for any further deterioration and reset as required

**Finding:** There are a number of loose posts around the fence  
**Action:** Monitor for any further deterioration and reset as required

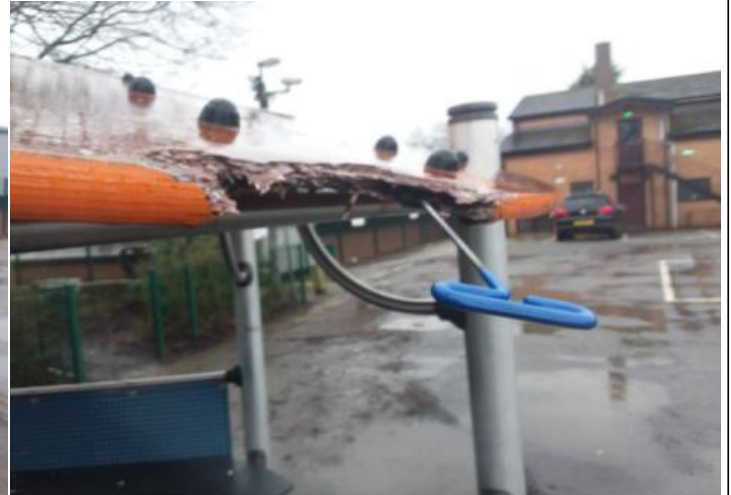
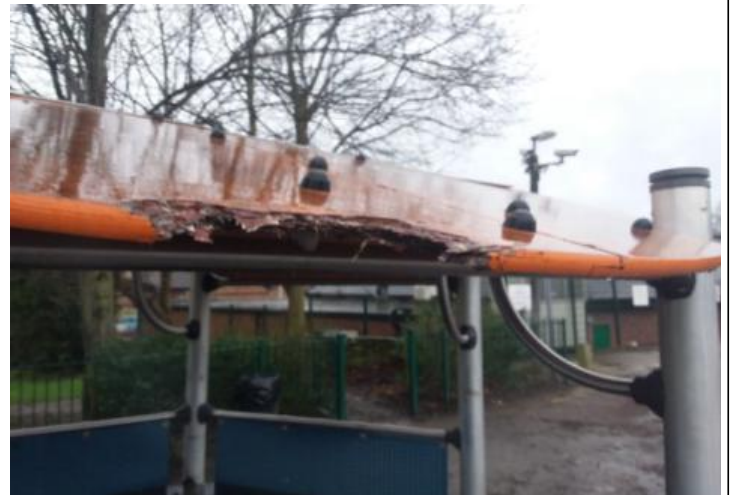
There are areas or parts of the timber roof on the structure that have rotted - Replace all affected timbers

**Finding:** There are areas or parts of the timber roof on the structure that have rotted

**Action:** Replace all affected timbers

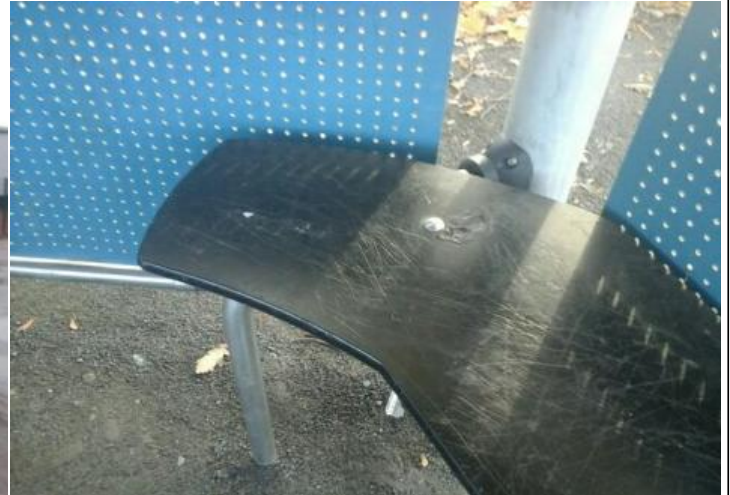
There is some evidence of fire damage to the item - Monitor for any further deterioration and repair as required

**Finding:** There is some evidence of fire damage to the item **Action:** Monitor for any further deterioration and repair as required

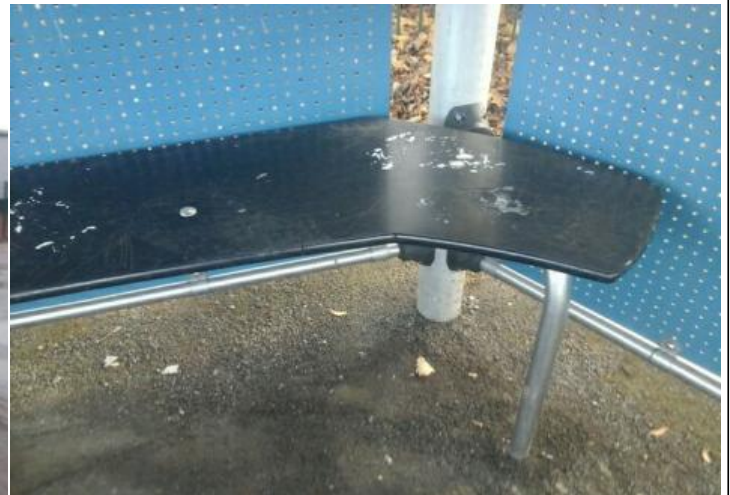
There is minor damage to the seats - Monitor for any further damage and repair as required

**Finding:** There is minor damage to the seats **Action:** Monitor for any further damage and repair as required

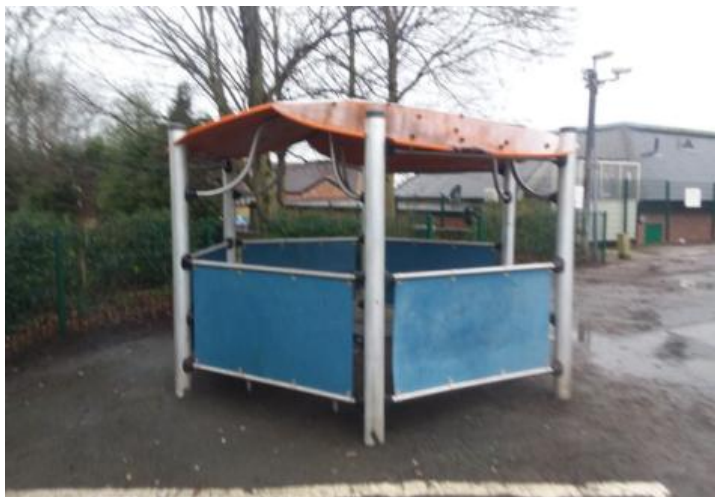
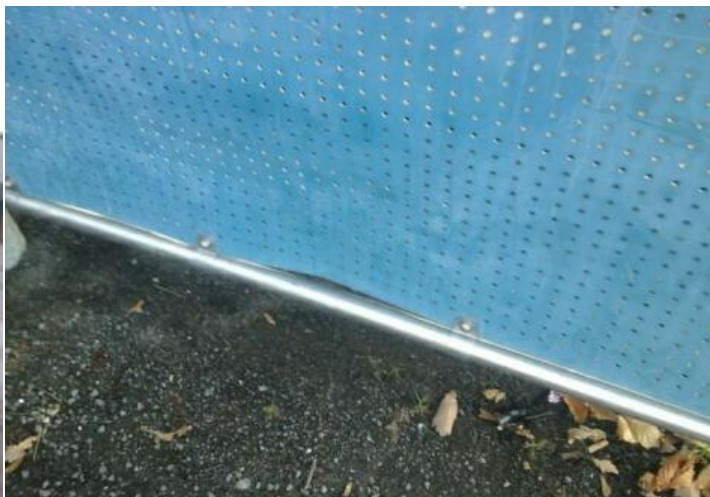
There is damage to the barrier - Monitor for any further deterioration and repair as required

**Finding:** There is damage to the barrier

**Action:** Monitor for any further deterioration and repair as required

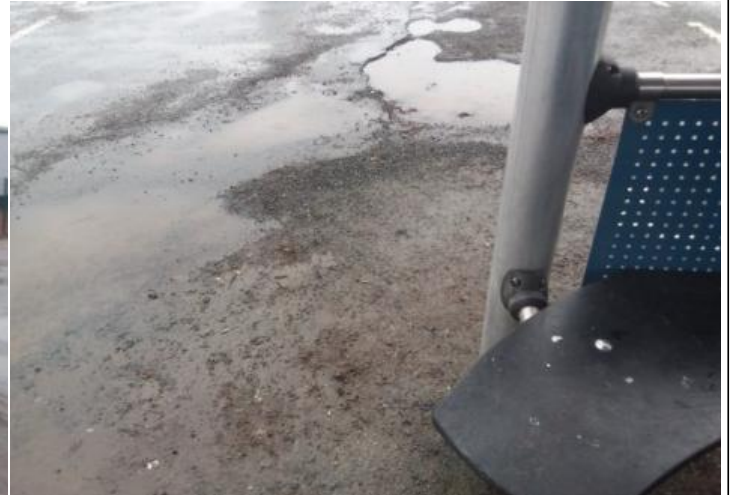
The bitumen surface is worn or damaged - Repair the bitumen to provide a uniform surface

**Finding:** The bitumen surface is worn or damaged

**Action:** Repair the bitumen to provide a uniform surface

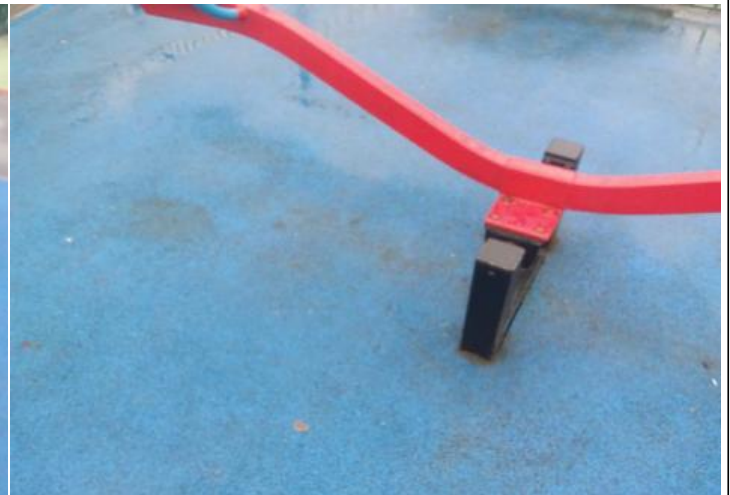
The safety surface under the seats is beginning to wear - Monitor for any further deterioration and repair as required

**Finding:** The safety surface under the seats is beginning to wear

**Action:** Monitor for any further deterioration and repair as required

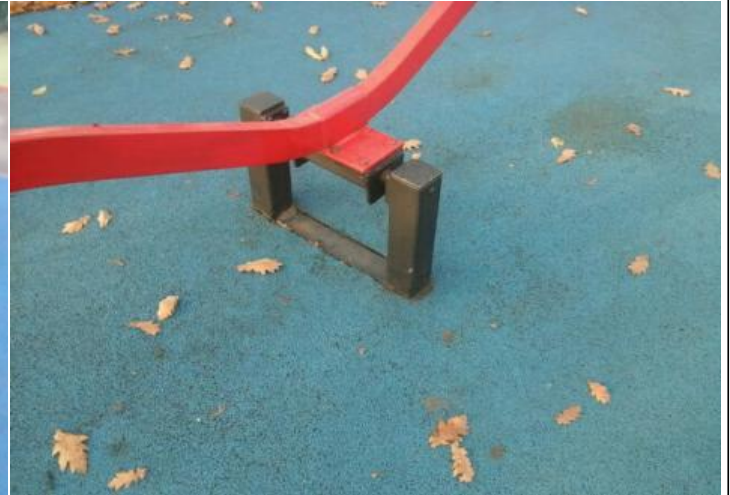
The item is slightly loose in its foundations - Monitor for any further deterioration and repair as required

**Finding:** The item is slightly loose in its foundations

**Action:** Monitor for any further deterioration and repair as required

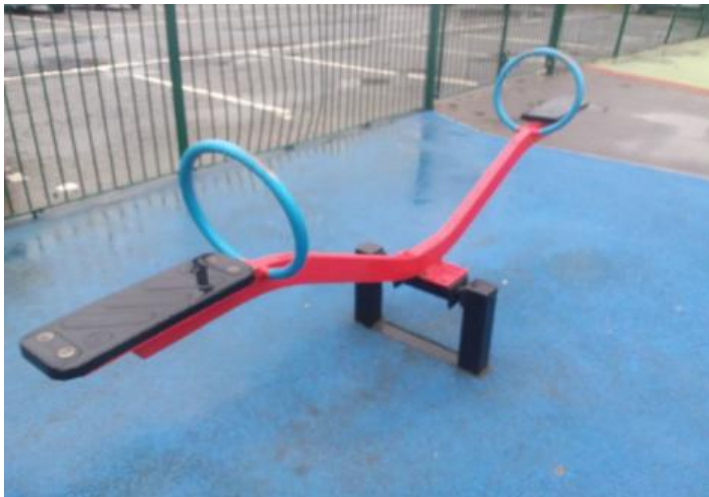
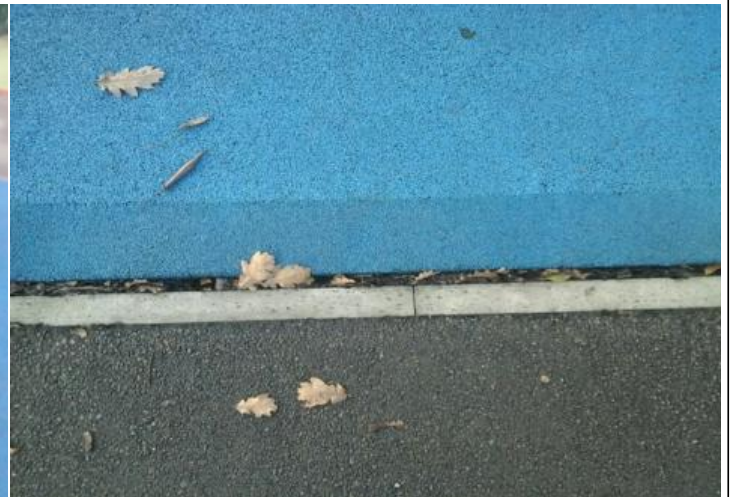
There are gaps opening between the surfacing and the edging surround or between the joints in the surfacing - Monitor for any further deterioration and repair as required

**Finding:** There are gaps opening between the surfacing and the edging surround or between the joints in the surfacing

**Action:** Monitor for any further deterioration and repair as required

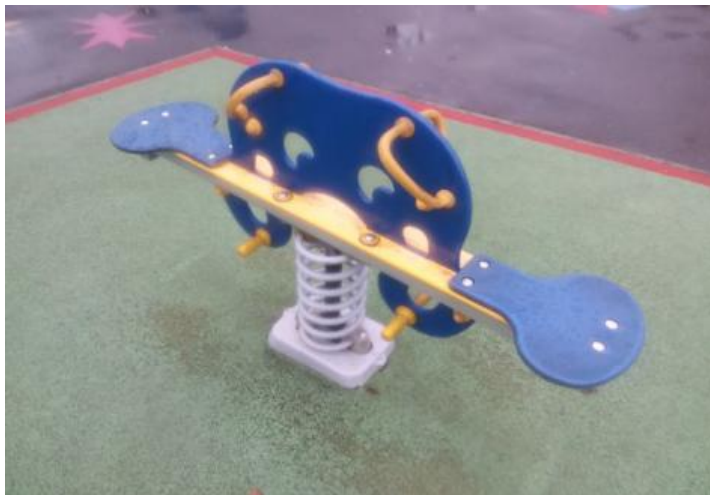
The U bolts clamping the spring are worn or loose - Monitor for any further deterioration and replace or resecure as required

**Finding:** The U bolts clamping the spring are worn or loose

**Action:** Monitor for any further deterioration and replace or resecure as required

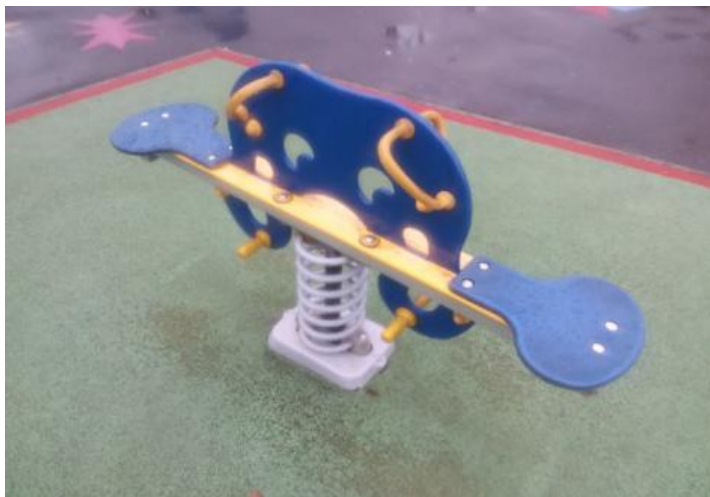
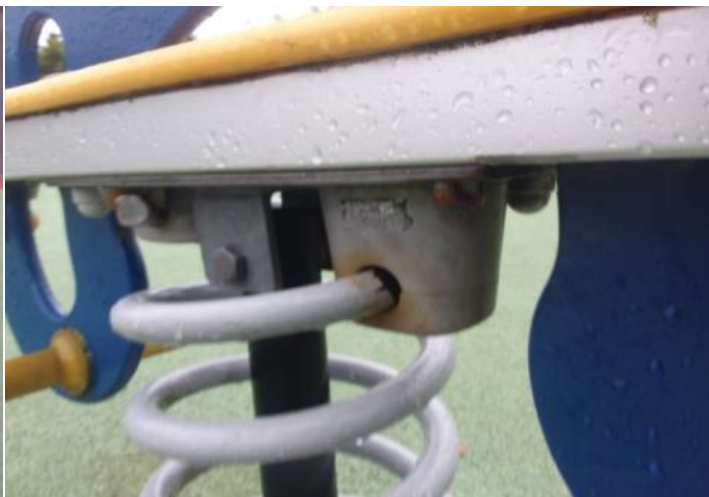
There is/are bolt cap covers missing or damaged on the item - Replace missing or damaged bolt cap covers

**Finding:** There is/are bolt cap covers missing or damaged on the item

**Action:** Replace missing or damaged bolt cap covers

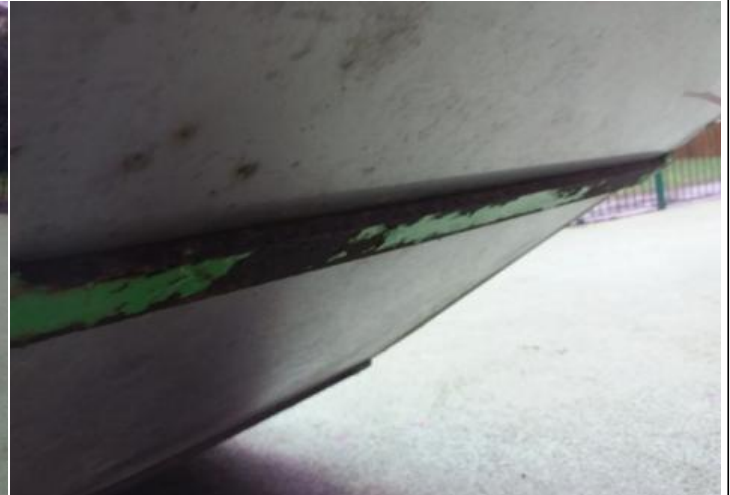
The paintwork on this item has been damaged or worn exposing the metal underneath which is rusting - Treat any rusting components and repaint

**Finding:** The paintwork on this item has been damaged or worn exposing the metal underneath which is rusting

**Action:** Treat any rusting components and repaint

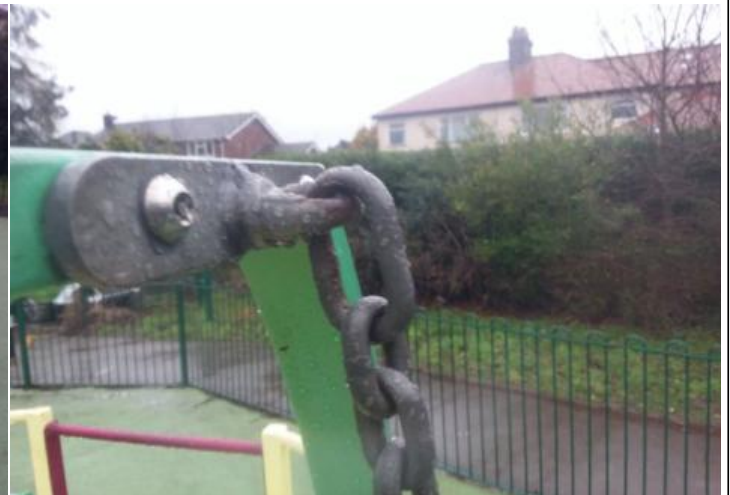
There is some notable evidence of chain wear - Monitor for any further deterioration and replace when 40% worn

**Finding:** There is some notable evidence of chain wear

**Action:** Monitor for any further deterioration and replace when 40% worn

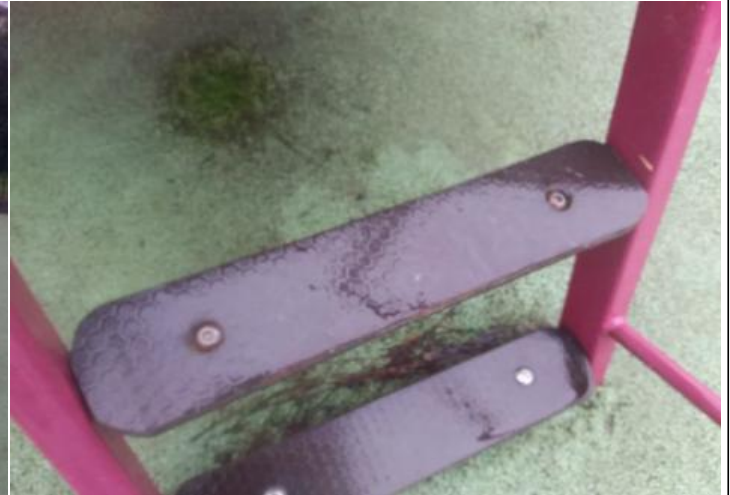
A number of fixing(s) have worked loose - Secure all loose fixings

**Finding:** A number of fixing(s) have worked loose

**Action:** Secure all loose fixings

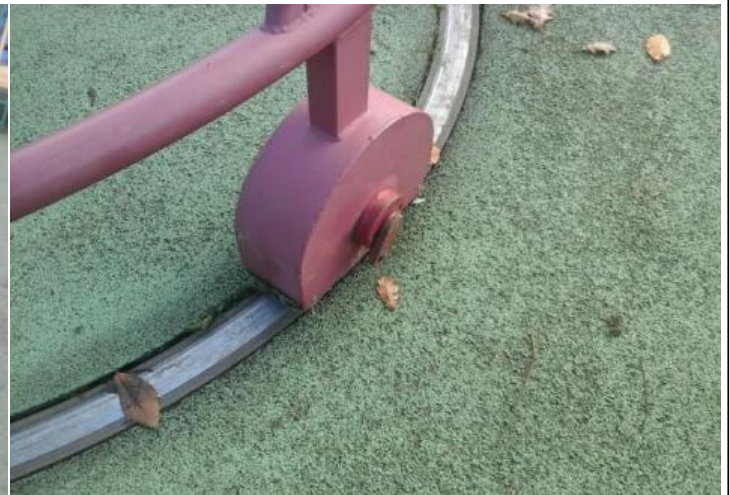
The pedals are missing from one of the cycles - Replace the pedals as required

**Finding:** The pedals are missing from one of the cycles

**Action:** Replace the pedals as required

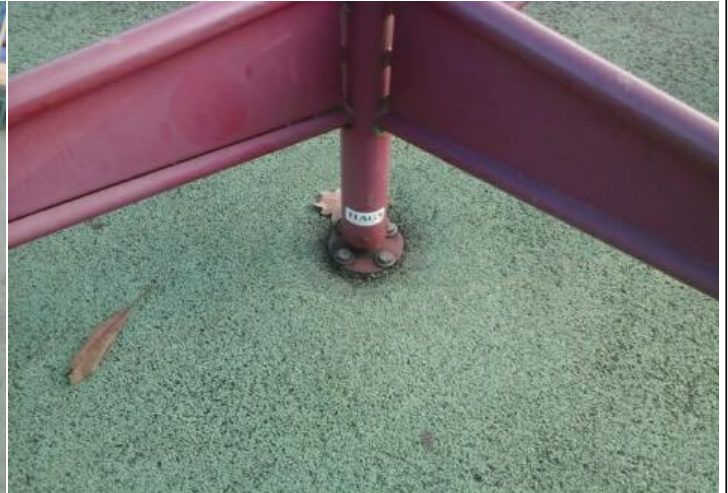
The item spindle is slightly loose in its foundations - Monitor for any further deterioration and repair as required

**Finding:** The item spindle is slightly loose in its foundations

**Action:** Monitor for any further deterioration and repair as required

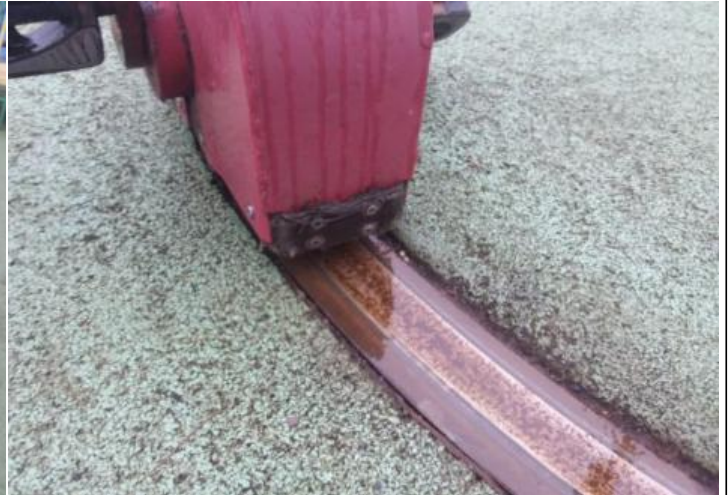
There is wear to the guards/covers - Monitor for any further deterioration and repair as required.

**Finding:** There is wear to the guards/covers

**Action:** Monitor for any further deterioration and repair as required.

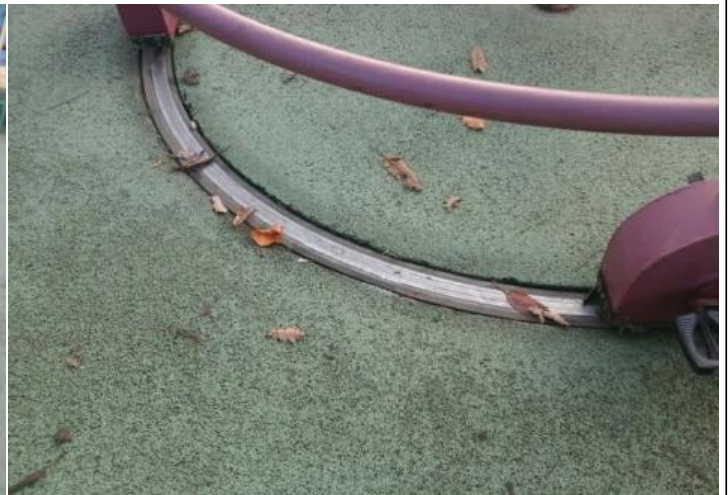
The running ring is slightly loose in its foundations - Monitor for any further deterioration and repair as required

**Finding:** The running ring is slightly loose in its foundations

**Action:** Monitor for any further deterioration and repair as required

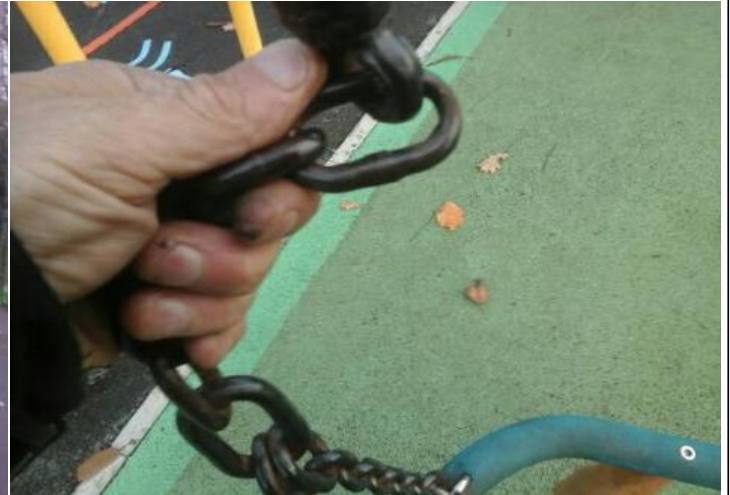
There is some chain wear - Monitor for any further deterioration and replace when 40% worn

**Finding:** There is some chain wear

**Action:** Monitor for any further deterioration and replace when 40% worn

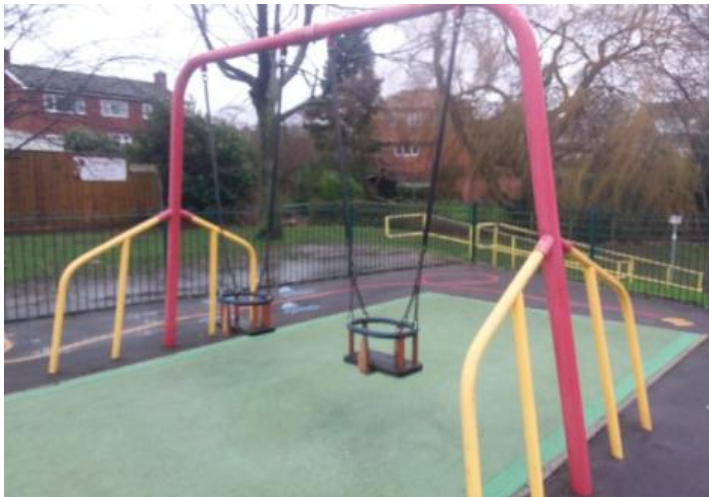
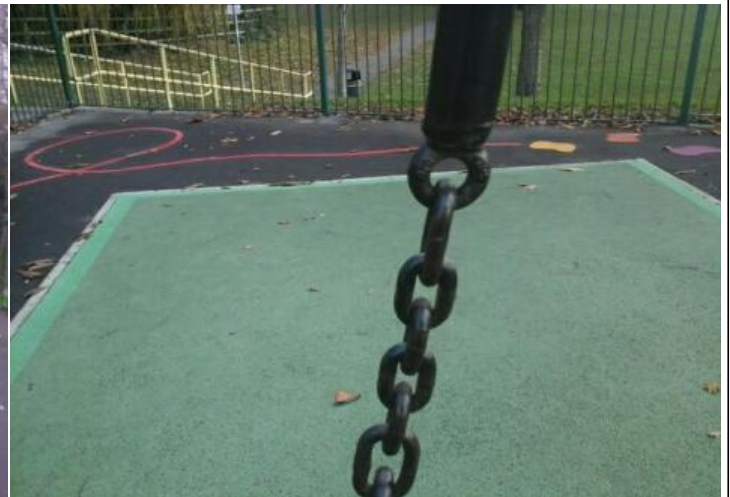
There is wear to the suspension bar eyes - Monitor for further wear and replace when 40 %worn

**Finding:** There is wear to the suspension bar eyes

**Action:** Monitor for further wear and replace when 40% worn

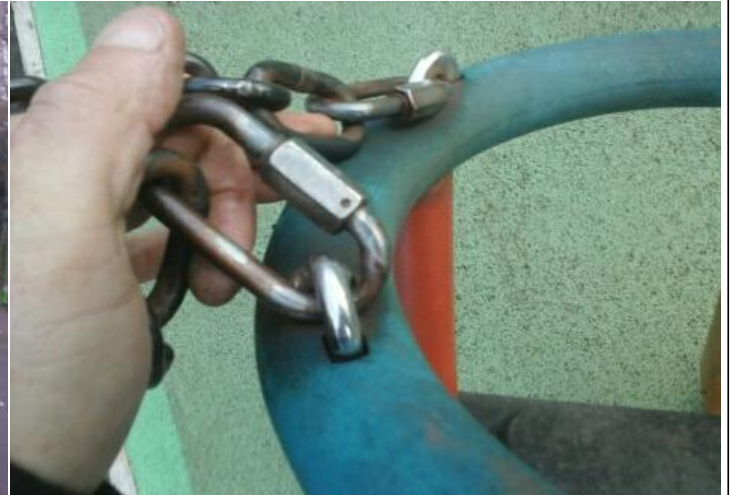
The shackles are worn in excess of 40% and require renewing - Replace worn shackles

**Finding:** The shackles are worn in excess of 40% and require renewing

**Action:** Replace worn shackles

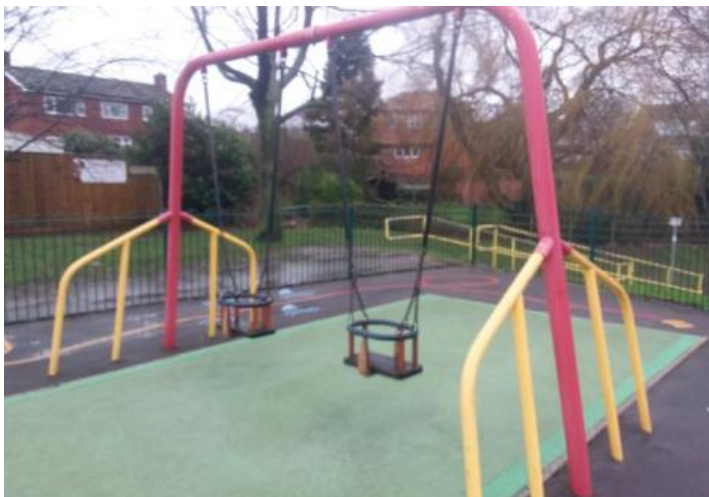
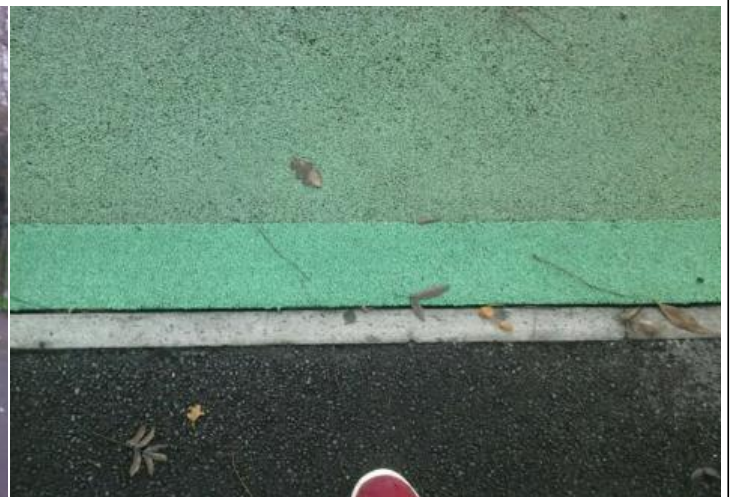
**Finding:** There are gaps opening between the surfacing and the edging surround or between the joints in the surfacing

**Action:** Monitor for any further deterioration and repair as required

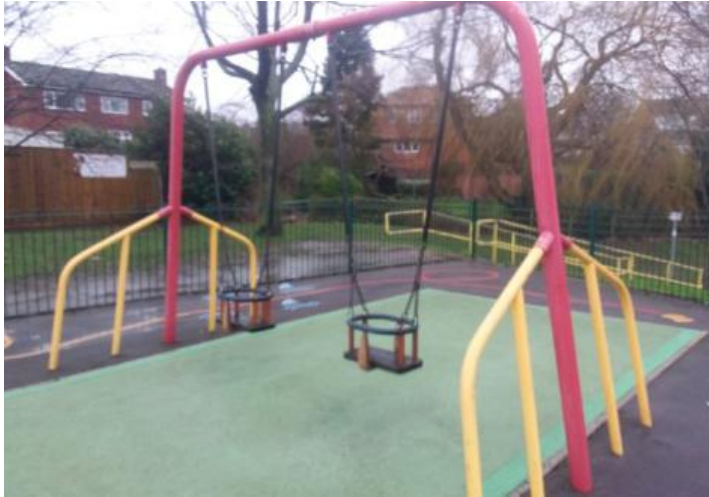
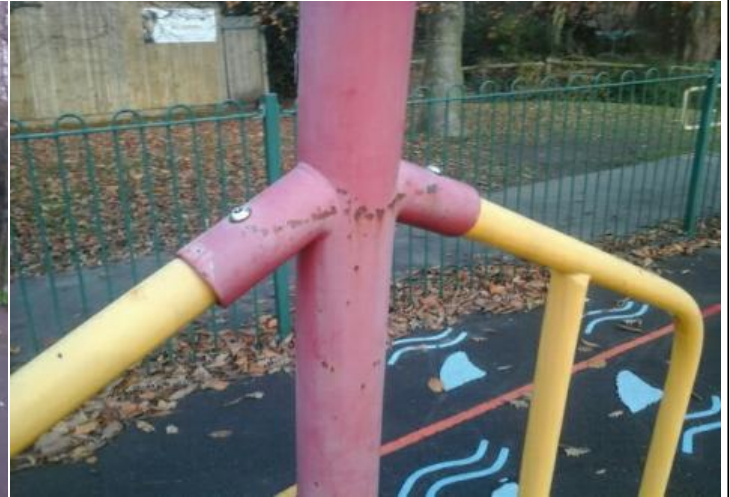
The paintwork on this item has been damaged or worn exposing the metal underneath which is rusting - Treat any rusting components and repaint

**Finding:** The paintwork on this item has been damaged or worn exposing the metal underneath which is rusting

**Action:** Treat any rusting components and repaint

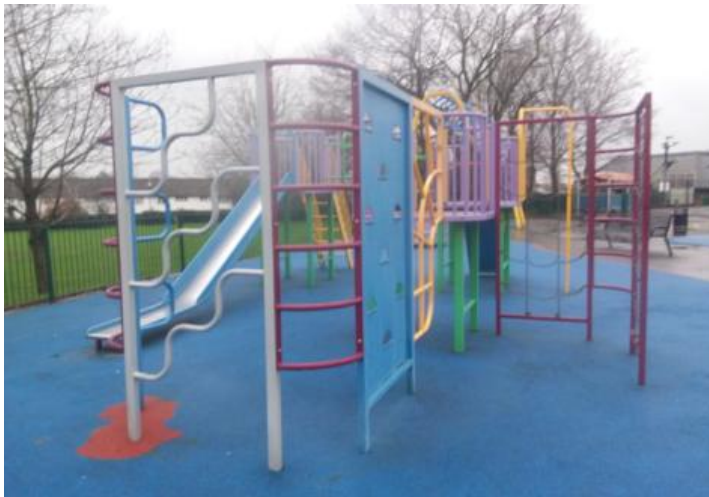
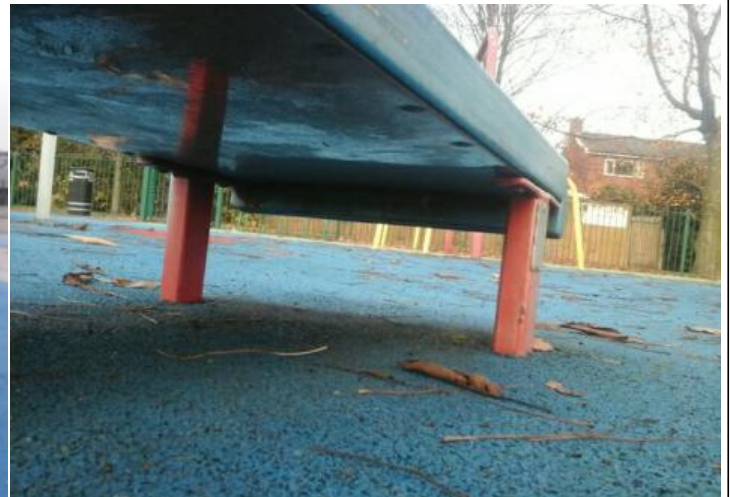
The slide runout support cross beam is corroding - Monitor for any further deterioration and repair 8

**Finding:** The slide runout support cross beam is corroding

**Action:** Monitor for any further deterioration and repair 8

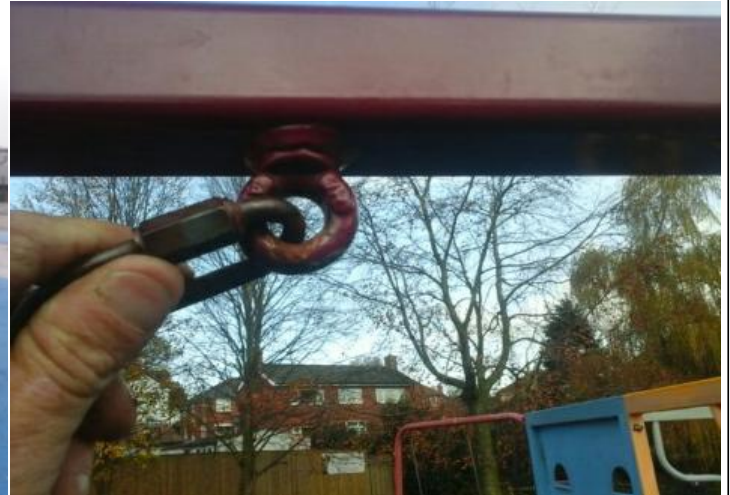
There is wear to the chain connecting lugs - Monitor for any further wear and replace when 40 % worn

**Finding:** There is wear to the chain connecting lugs

**Action:** Monitor for any further wear and replace when 40 % worn

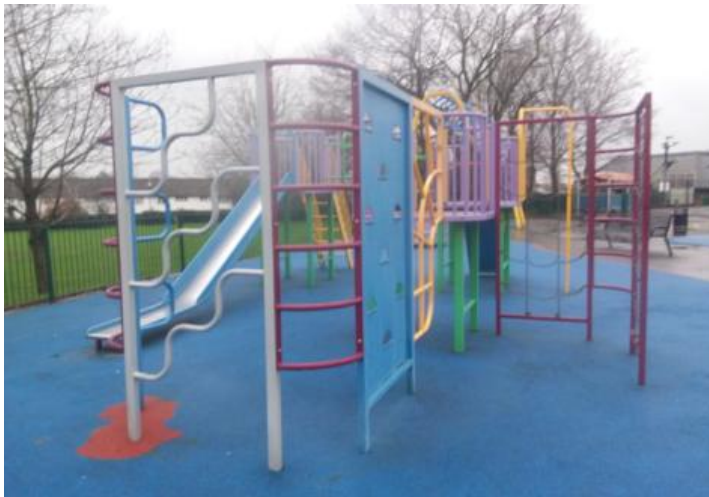
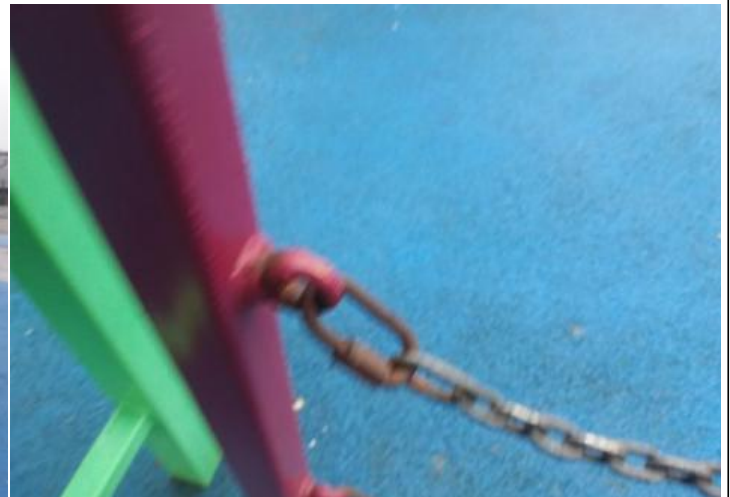
The shackles to the chain net are corroding - Monitor for any further deterioration and replace as required

**Finding:** The shackles to the chain net are corroding

**Action:** Monitor for any further deterioration and replace as required

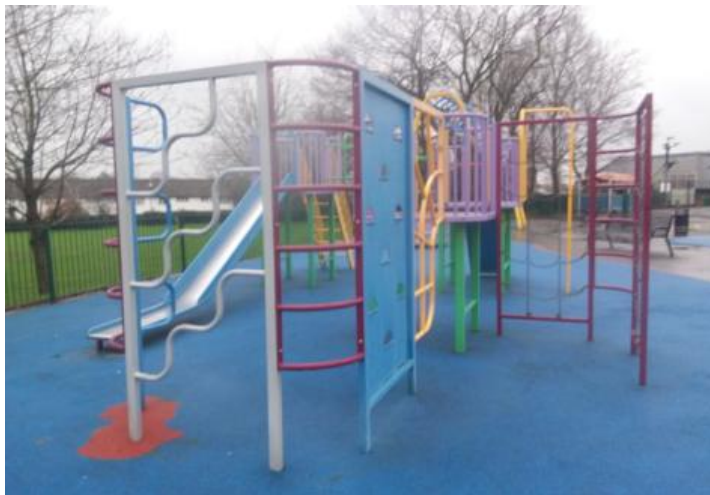
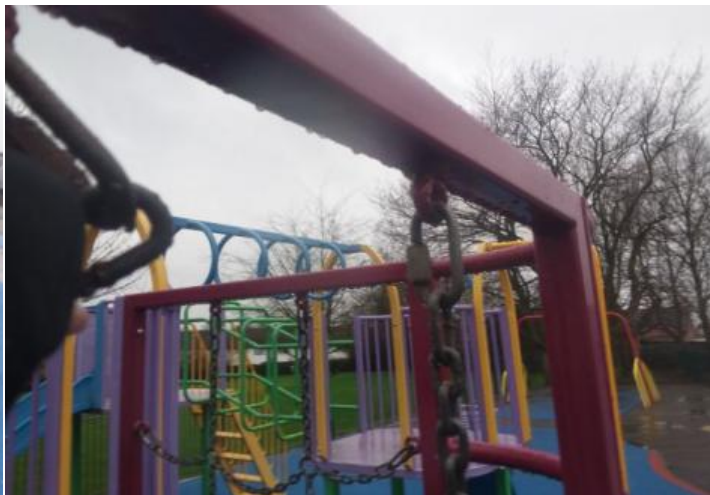
There is some wear to the shackles on the chain net - Monitor for any further deterioration and replace when 40% worn

**Finding:** There is some wear to the shackles on the chain net

**Action:** Monitor for any further deterioration and replace when 40% worn

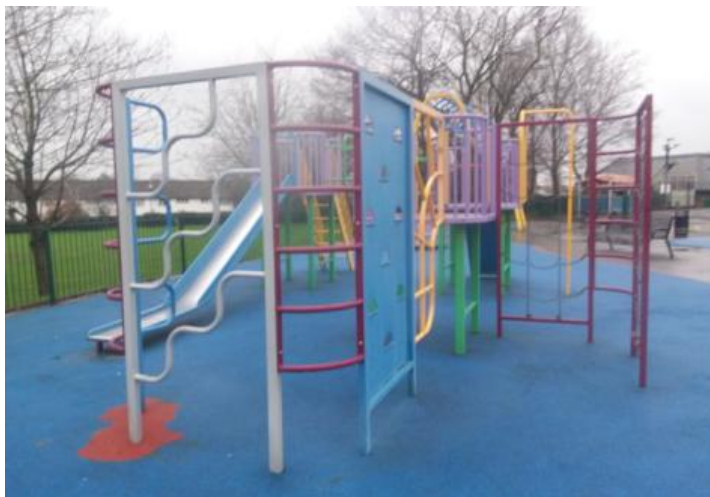
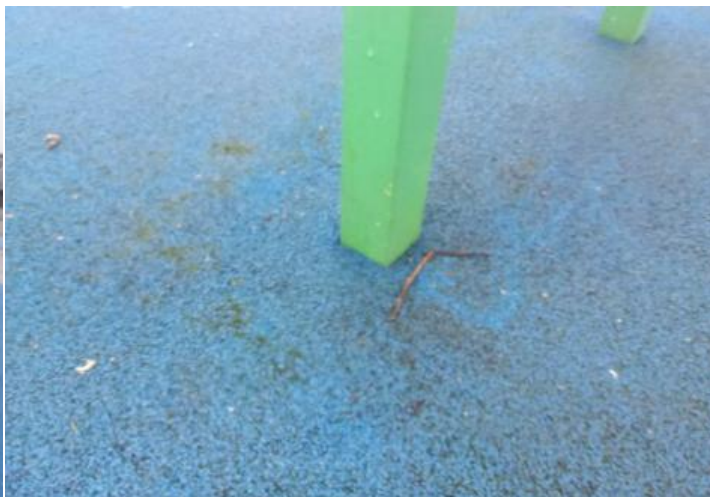
**Finding:** There is algae or moss growth on the surface resulting in slippery conditions

**Action:** Clean and treat appropriately

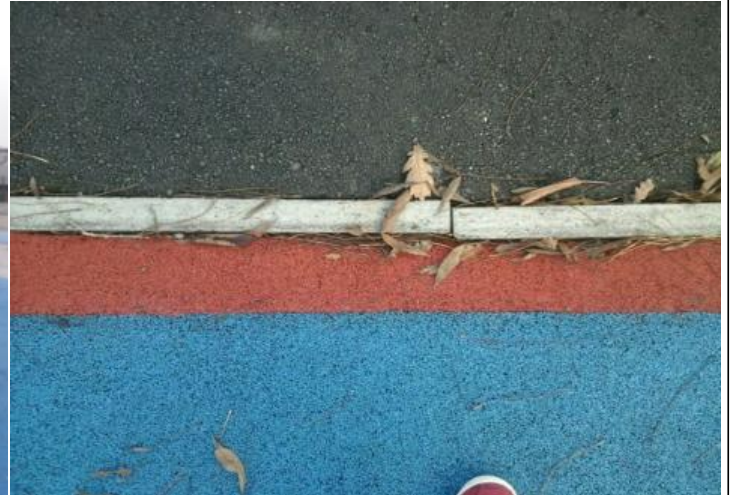
**Finding:** There are gaps opening between the surfacing and the edging surround or between the joints in the surfacing  
**Action:** Monitor for any further deterioration and repair as required

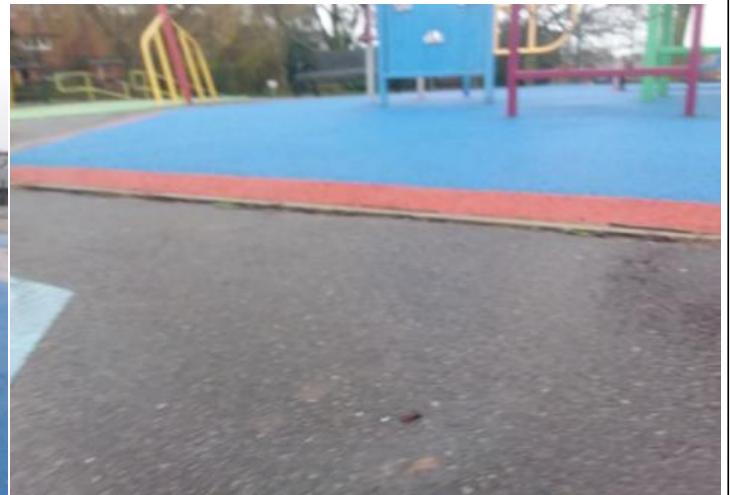
**Finding:** There are trip hazards at the edges of the surface  
**Action:** Reinstall surrounding surface levels to remove the trip points

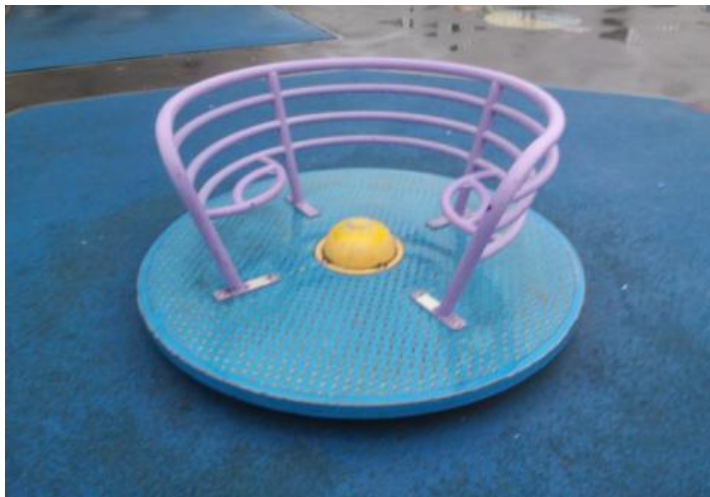
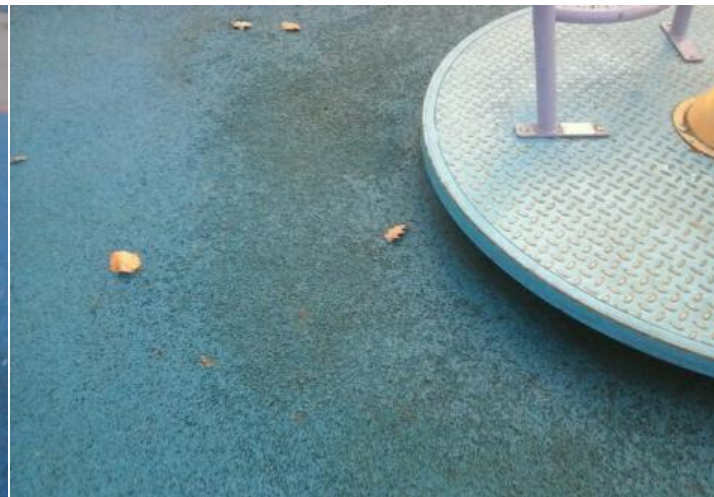
**Finding:** The safety surface around the area is beginning to wear  
**Action:** Monitor for any further deterioration and repair as required

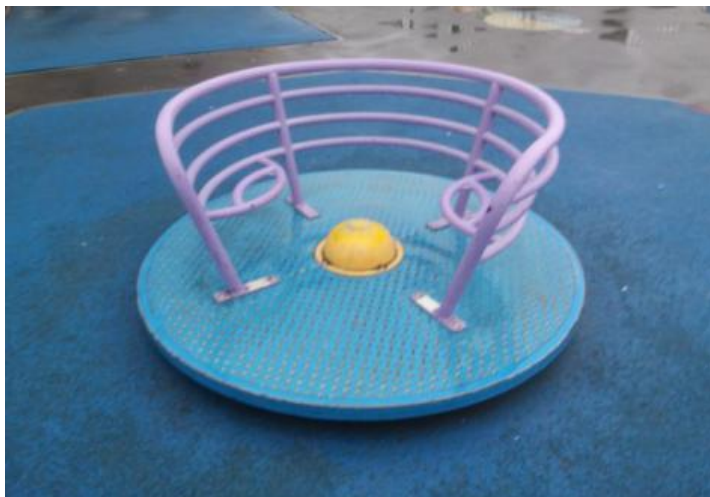
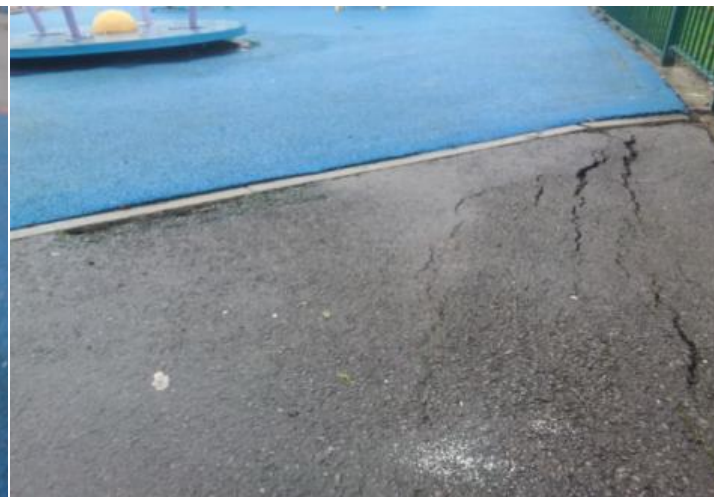
**Finding:** There are trip hazards at the edges of the surface  
**Action:** Reinstate surrounding surface levels to remove the trip points
