## Operational Inspection

Tarporley Parish Council

Tarporley Community Centre

Operational Inspection - 8-February-2019 - 08:31 Inspector John-Aris Hirst (RPII Annual Inspector)

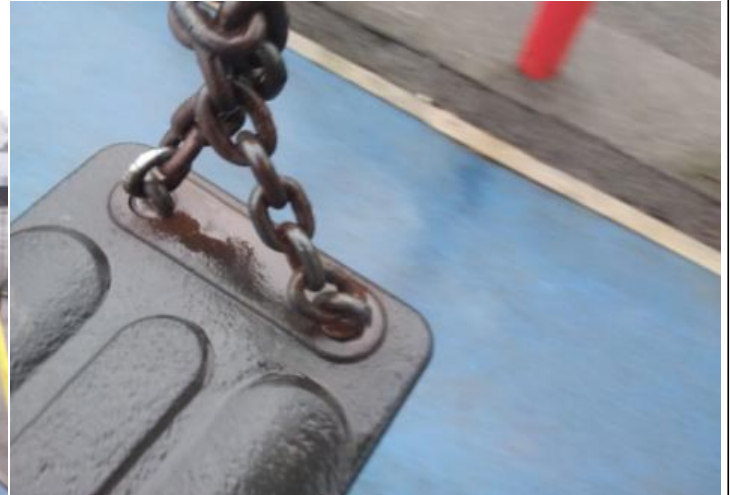
The swing seat connectors are loose - Tighten to secure

**Finding:** The swing seat connectors are loose

**Action:** Tighten to secure

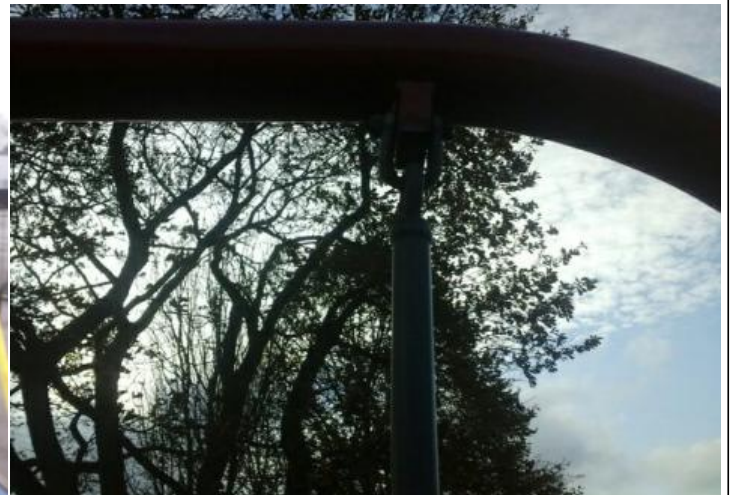
There is some wear to the shackles. - Monitor for any further deterioration and replace when 40% worn

**Finding:** There is some wear to the shackles.

**Action:** Monitor for any further deterioration and replace when 40% worn

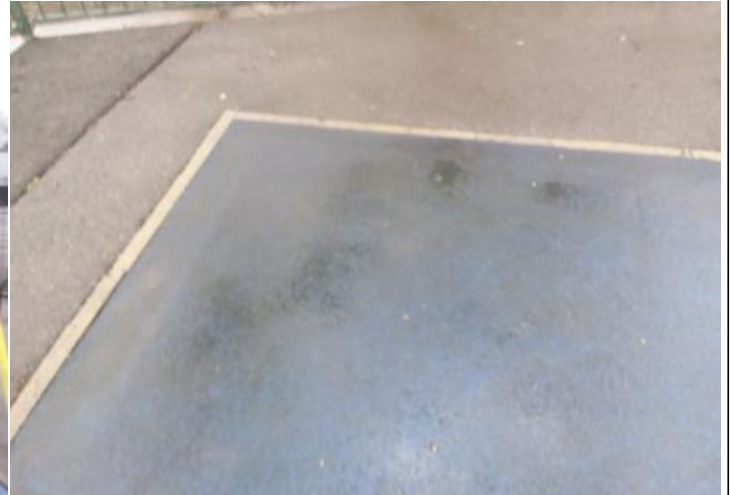
**Finding:** There is algae or moss growth on the surface resulting in slippery conditions

**Action:** Clean and treat appropriately

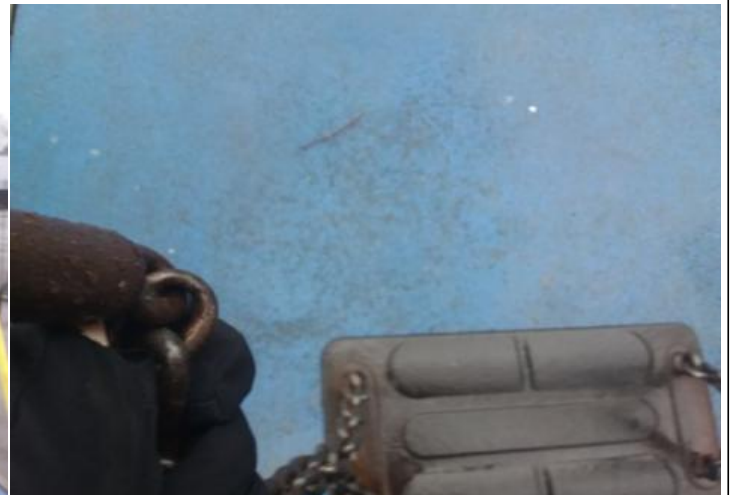
The chain links are worn in excess of 40% and require renewing - Replace worn chains

**Finding:** The chain links are worn in excess of 40% and require renewing

**Action:** Replace worn chains

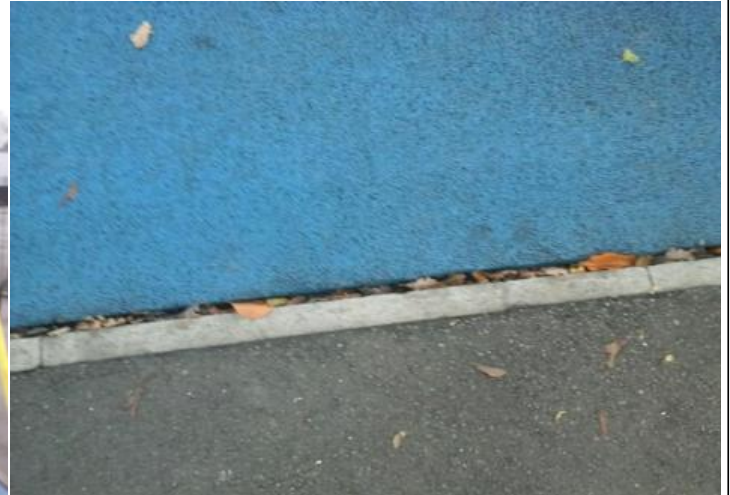
**Finding:** There are gaps opening between the surfacing and the edging surround or between the joints in the surfacing  
**Action:** Monitor for any further deterioration and repair as required

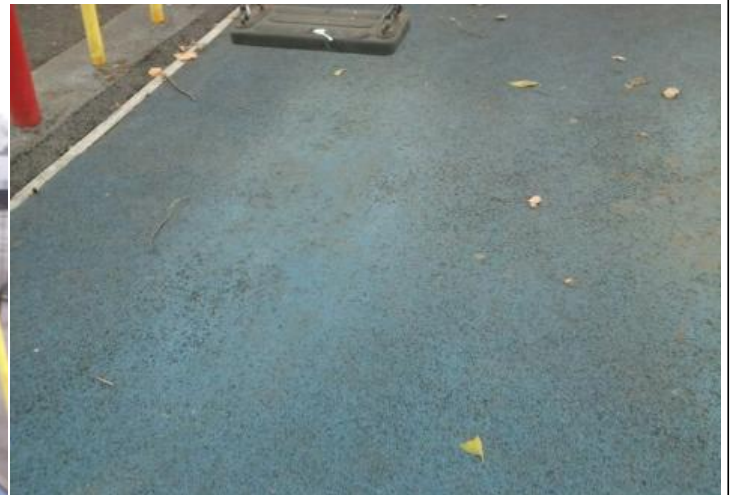
**Finding:** The safety surface around the area is beginning to wear  
**Action:** Monitor for any further deterioration and repair as required

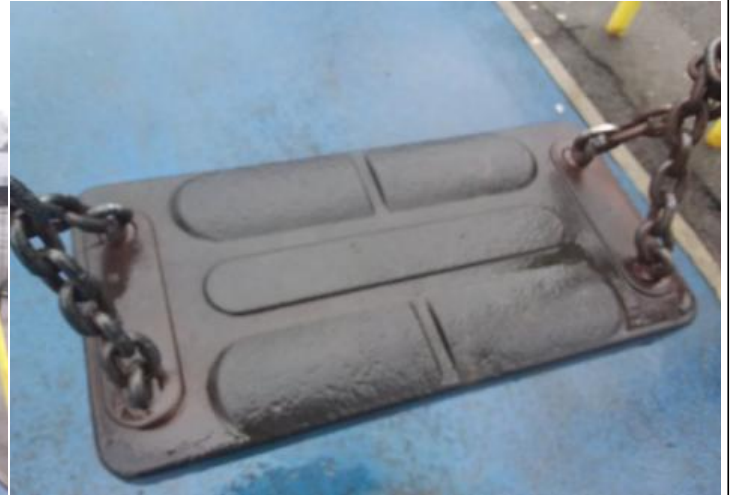
The seat has minor damage or wear - Monitor for any further deterioration and replace as required

**Finding:** The seat has minor damage or wear

**Action:** Monitor for any further deterioration and replace as required

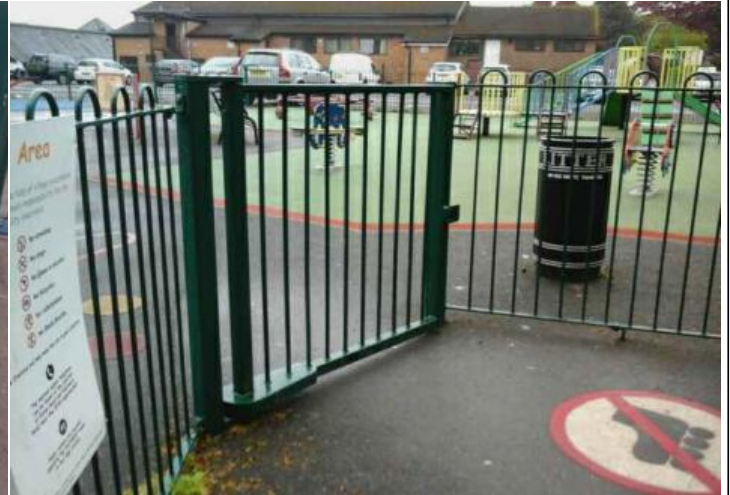
**Finding:** The gate is not a contrasting colour to the fencing making it difficult for users with impaired sight to distinguish it from the fence

**Action:** We would recommend that the gates are painted a distinguishable colour to that of the fence

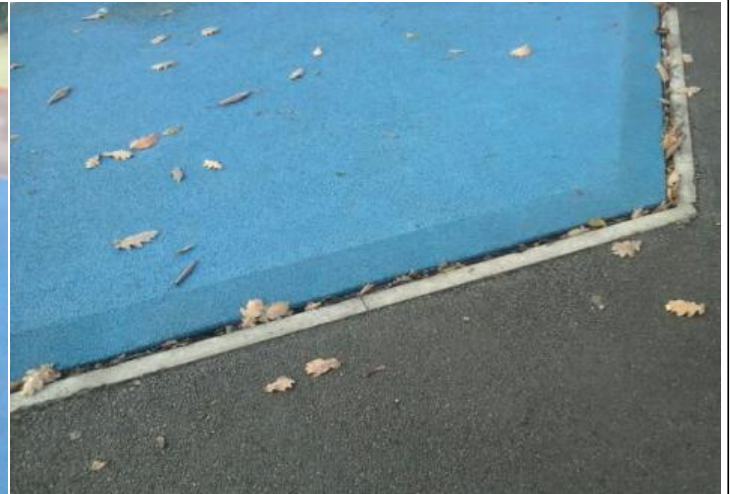
**Finding:** The surface is lifting at the edges and creating trip points

**Action:** Repair perimeter of surfacing to remove trip points

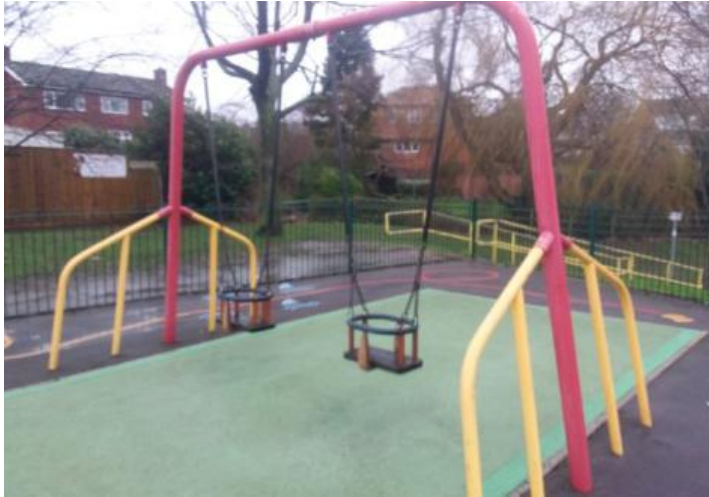
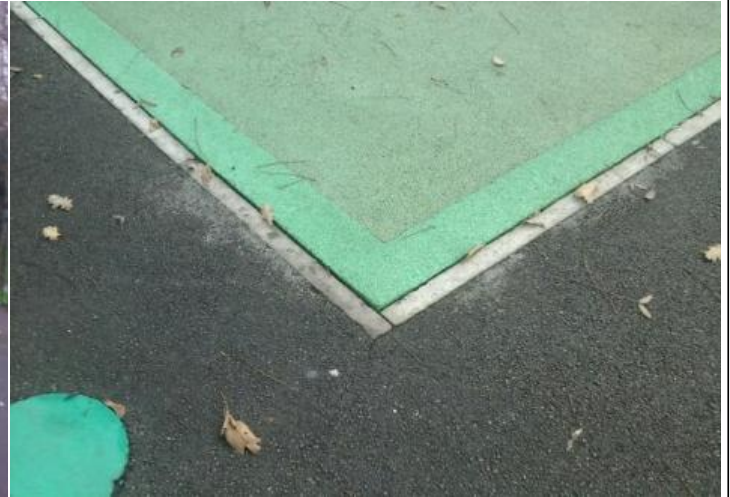
**Finding:** The surface is lifting at the edges and creating trip points **Action:** Repair perimeter of surfacing to remove trip points

8 - Low Risk (Finding 1) - **Marked as complete on 8-February-2019**

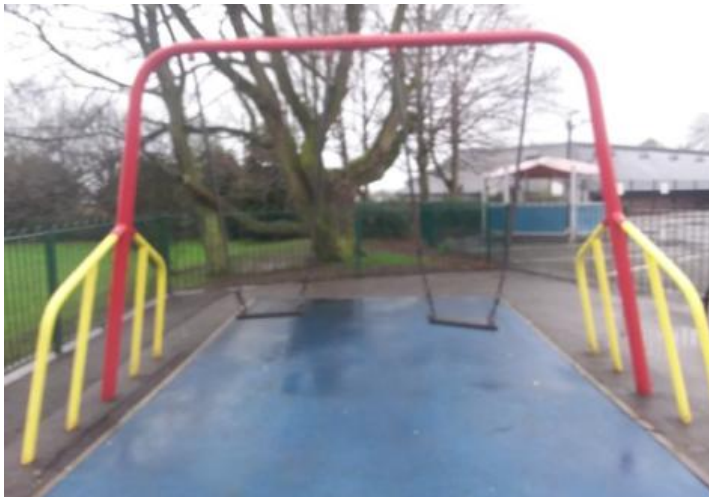
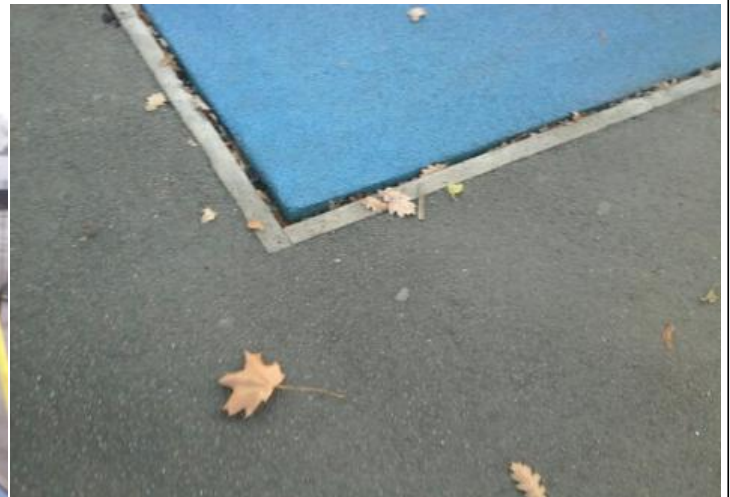
**Finding:** The surface is lifting at the edges and creating trip points **Action:** Repair perimeter of surfacing to remove trip points
