## Operational Inspection

Tarporley Parish Council

Tarporley Community Centre

Operational Inspection - 8-February-2019 - 08:31 Inspector John-Aris Hirst (RPII Annual Inspector)

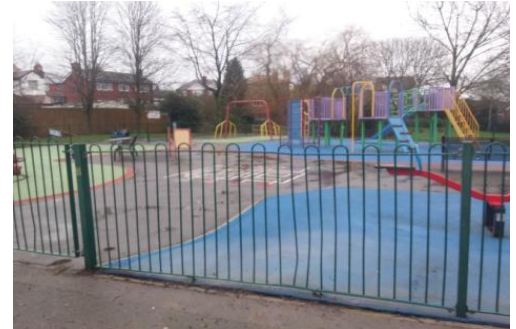
**Item:** Site General  
**Manufacturer:** Owner/Operator  
**Surface Type:** N/A  
**Equipment Compliance:** N/A  
**Surface Area Compliance:** N/A

The surface is lifting at the edges and creating trip points - Repair perimeter of surfacing to remove trip points

There is a redundant spring base present - Replace the missing springer or remove the base and repair the surface

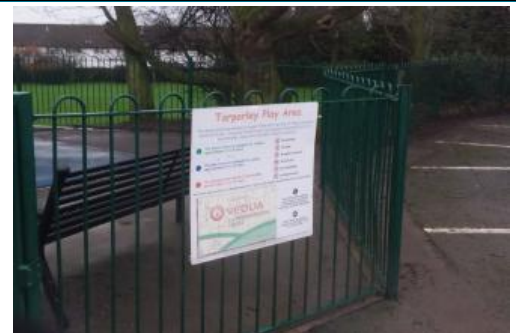
**Item:** Sign  
**Manufacturer:** Owner/Operator  
**Surface Type:** N/A  
**Equipment Compliance:** N/A  
**Surface Area Compliance:** N/A

This item is satisfactory - no work required -

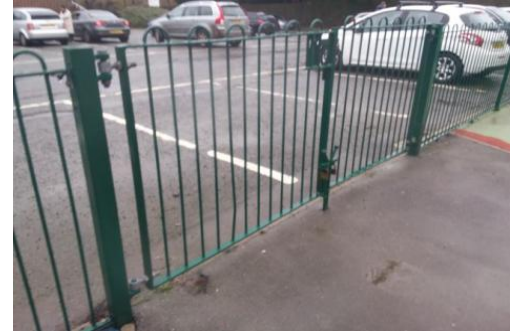
**Item:** Maintenance Gate  
**Manufacturer:** Owner/Operator  
**Surface Type:** Bitmac  
**Equipment Compliance:** N/A  
**Surface Area Compliance:** N/A

The bitumen surface is worn or damaged - Repair the bitumen to provide a uniform surface

There is some damage to the infill bars - Repair or replace as required

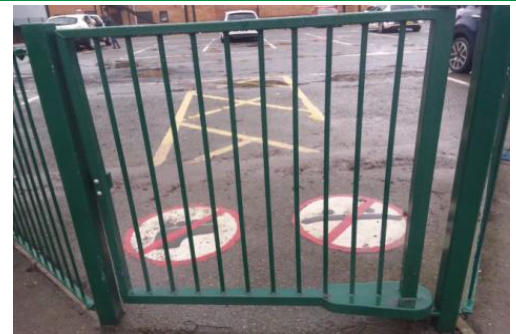
**Item:** Gate - Self Closing  
**Manufacturer:** Owner/Operator  
**Surface Type:** Bitmac  
**Equipment Compliance:** N/A  
**Surface Area Compliance:** N/A

**Finding:** The opening between the gate and the post is less than 12mm and could trap users fingers

**Finding:** The gate is not operating correctly

**Action:** Adjust gate to ensure a 12mm opening all around

**Action:** Take effective action to ensure the gate closes between 4 and 8 seconds

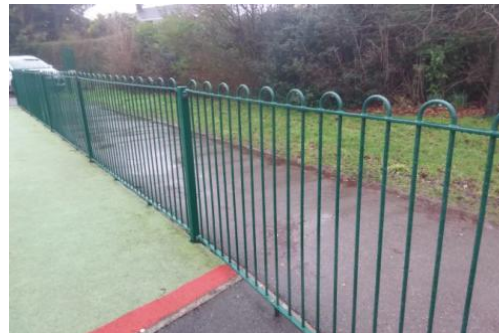
**Item:** Fence - Bow Top  
**Manufacturer:** Owner/Operator  
**Surface Type:** N/A  
**Equipment Compliance:** N/A  
**Surface Area Compliance:** N/A

There is some damage to the fence sections - Monitor for any further deterioration and repair as required

A number of fixings have worked loose around the fencing - Secure all loose fixings

There are a number of loose posts around the fence - Monitor for any further deterioration and reset as required

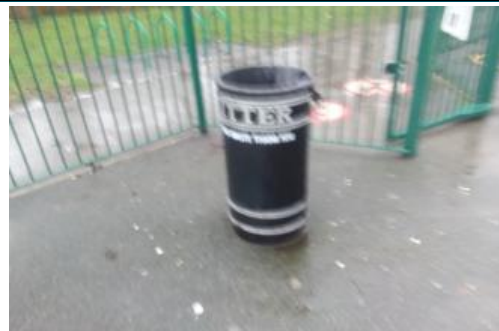
**Item:** Litter Bin  
**Manufacturer:** Owner/Operator  
**Surface Type:** Bitmac  
**Equipment Compliance:** N/A  
**Surface Area Compliance:** N/A

This item is satisfactory - no work required -

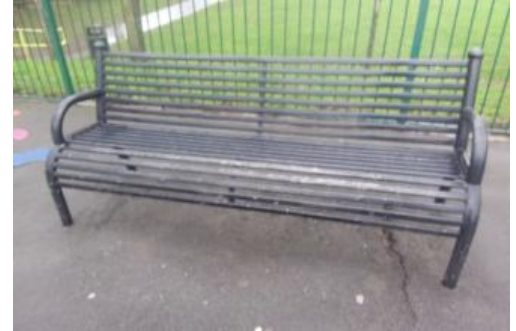
**Item:** Bench  
**Manufacturer:** Owner/Operator  
**Surface Type:** N/A  
**Equipment Compliance:** N/A  
**Surface Area Compliance:** N/A

This item is satisfactory - no work required -

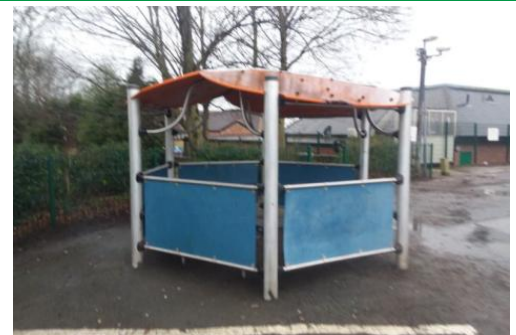
**Item:** Shelter  
**Manufacturer:** Proludic  
**Surface Type:** N/A  
**Equipment Compliance:** N/A  
**Surface Area Compliance:** N/A  
**Life Expectancy:** 3 - 5 Years

There is some graffiti present - Remove the graffiti

There is some evidence of fire damage to the item - Monitor for any further deterioration and repair as required

The bitumen surface is worn or damaged - Repair the bitumen to provide a uniform surface

There are areas or parts of the timber roof on the structure that have rotted - Replace all affected timbers

There is minor damage to the seats - Monitor for any further damage and repair as required

There is damage to the barrier - Monitor for any further deterioration and repair as required

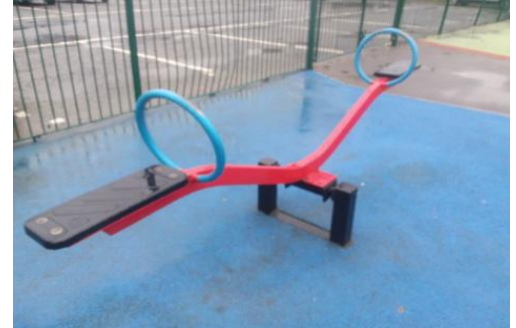
**Item:** See Saw  
**Manufacturer:** Record RSS  
**Surface Type:** Wet Pour  
**Equipment Compliance:** Yes  
**Surface Area Compliance:** Yes  
**Life Expectancy:** 5 -10 Years

The safety surface under the seats is beginning to wear - Monitor for any further deterioration and repair as required

There are gaps opening between the surfacing and the edging surround or between the joints in the surfacing - Monitor for any further deterioration and repair as required

The item is slightly loose in its foundations - Monitor for any further deterioration and repair as required

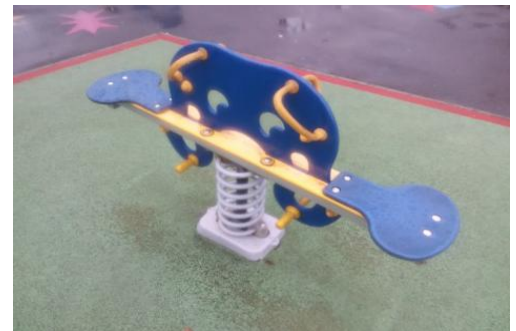
**Item:** Spring See-Saw  
**Manufacturer:** Ledon  
**Surface Type:** Wet Pour  
**Equipment Compliance:** No  
**Surface Area Compliance:** Yes  
**Life Expectancy:** 3 - 5 Years

The U bolts clamping the spring are worn or loose - Monitor for any further deterioration and replace or resecure as required

There is/are bolt cap covers missing or damaged on the item - Replace missing or damaged bolt cap covers

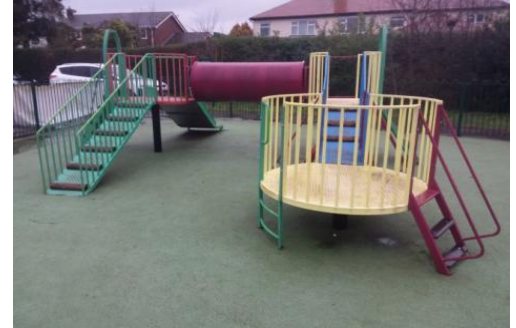
**Item:** Multi Play (Toddler)  
**Manufacturer:** Record RSS  
**Surface Type:** Wet Pour  
**Equipment Compliance:** No  
**Surface Area Compliance:** Yes  
**Life Expectancy:** >10 Years

The paintwork on this item has been damaged or worn exposing the metal underneath which is rusting - Treat any rusting components and repaint

A number of fixing(s) have worked loose - Secure all loose fixings

There is some notable evidence of chain wear - Monitor for any further deterioration and replace when 40% worn

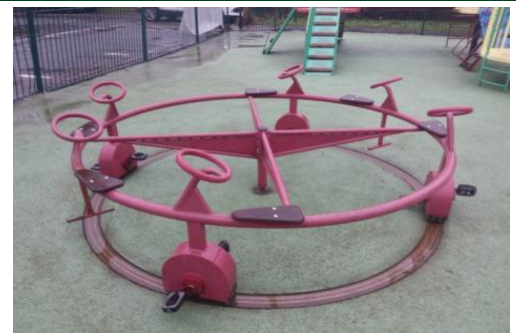
**Item:** Pedal Roundabout  
**Manufacturer:** Hags  
**Surface Type:** Wet Pour  
**Equipment Compliance:** Yes  
**Surface Area Compliance:** Yes  
**Life Expectancy:** 5 -10 Years

The pedals are missing from one of the cycles - Replace the pedals as required

The running ring is slightly loose in its foundations - Monitor for any further deterioration and repair as required

The item spindle is slightly loose in its foundations - Monitor for any further deterioration and repair as required

There is wear to the guards/covers - Monitor for any further deterioration and repair as required.

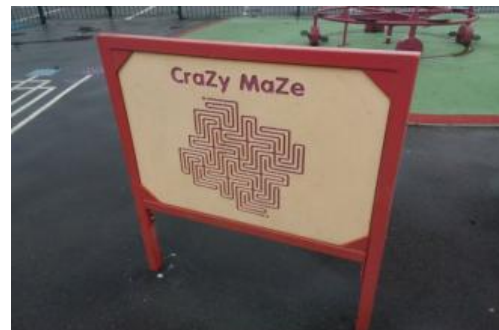
**Item:** Play Panel  
**Manufacturer:** Record RSS  
**Surface Type:** Bitmac  
**Equipment Compliance:** Yes  
**Surface Area Compliance:** Yes  
**Life Expectancy:** 5 -10 Years

This item is satisfactory - no work required -

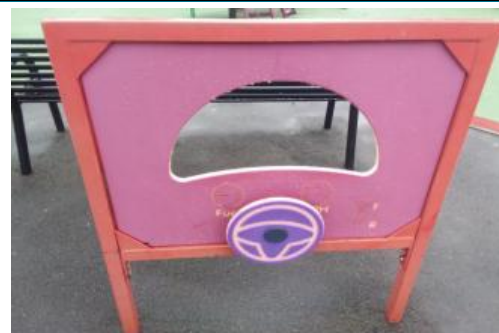
**Item:** Play Panel  
**Manufacturer:** Record RSS  
**Surface Type:** Bitmac  
**Equipment Compliance:** Yes  
**Surface Area Compliance:** Yes  
**Life Expectancy:** 5 -10 Years

This item is satisfactory - no work required -

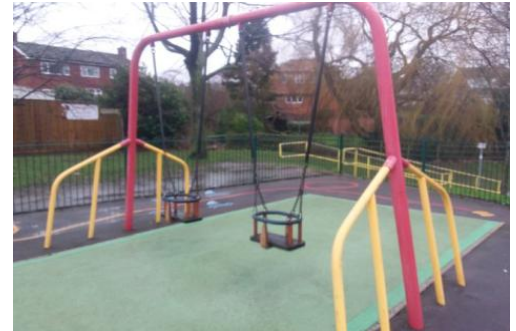
**Item:** 1 Bay 2 Seat (Cradle)  
**Manufacturer:** Record RSS  
**Surface Type:** Wet Pour  
**Equipment Compliance:** No  
**Surface Area Compliance:** Yes  
**Life Expectancy:** >10 Years

There is some chain wear - Monitor for any further deterioration and replace when 40% worn

The shackles are worn in excess of 40% and require renewing - Replace worn shackles

The paintwork on this item has been damaged or worn exposing the metal underneath which is rusting - Treat any rusting components and repaint

There is wear to the suspension bar eyes - Monitor for further wear and replace when 40 %worn

There are gaps opening between the surfacing and the edging surround or between the joints in the surfacing - Monitor for any further deterioration and repair as required

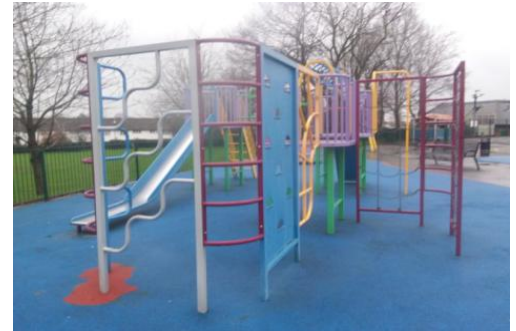
**Item:** Multi Play (Junior)  
**Manufacturer:** Record RSS  
**Surface Type:** Wet Pour  
**Equipment Compliance:** No  
**Surface Area Compliance:** Yes  
**Life Expectancy:** >10 Years

The slide runout support cross beam is corroding - Monitor for any further deterioration and repair 8

The shackles to the chain net are corroding - Monitor for any further deterioration and replace as required

There is algae or moss growth on the surface resulting in slippery conditions - Clean and treat appropriately

There are trip hazards at the edges of the surface - Reinstate surrounding surface levels to remove the trip points

There is wear to the chain connecting lugs - Monitor for any further wear and replace when 40 % worn

There is some wear to the shackles on the chain net - Monitor for any further deterioration and replace when 40% worn

There are gaps opening between the surfacing and the edging surround or between the joints in the surfacing - Monitor for any further deterioration and repair as required

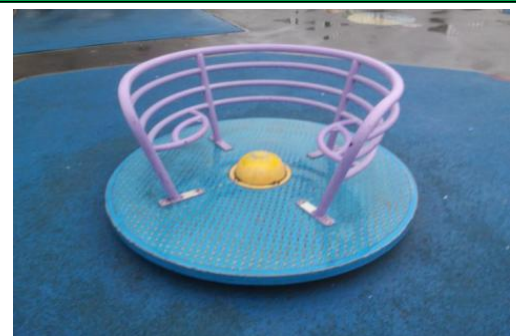
**Item:** Roundabout  
**Manufacturer:** Record RSS  
**Surface Type:** Wet Pour  
**Equipment Compliance:** No  
**Surface Area Compliance:** Yes  
**Life Expectancy:** 5 -10 Years

The safety surface around the area is beginning to wear - Monitor for any further deterioration and repair as required

There are trip hazards at the edges of the surface - Reinstate surrounding surface levels to remove the trip points

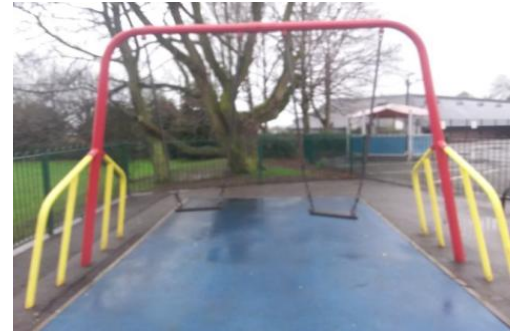
**Item:** 1 Bay 2 Seat (Flat)  
**Manufacturer:** Record RSS  
**Surface Type:** Wet Pour  
**Equipment Compliance:** No  
**Surface Area Compliance:** No  
**Life Expectancy:** >10 Years

The swing seat connectors are loose - Tighten to secure

There is algae or moss growth on the surface resulting in slippery conditions - Clean and treat appropriately

There are gaps opening between the surfacing and the edging surround or between the joints in the surfacing - Monitor for any further deterioration and repair as required

The seat has minor damage or wear - Monitor for any further deterioration and replace as required

There is some wear to the shackles. - Monitor for any further deterioration and replace when 40% worn

The chain links are worn in excess of 40% and require renewing - Replace worn chains

The safety surface around the area is beginning to wear - Monitor for any further deterioration and repair as required

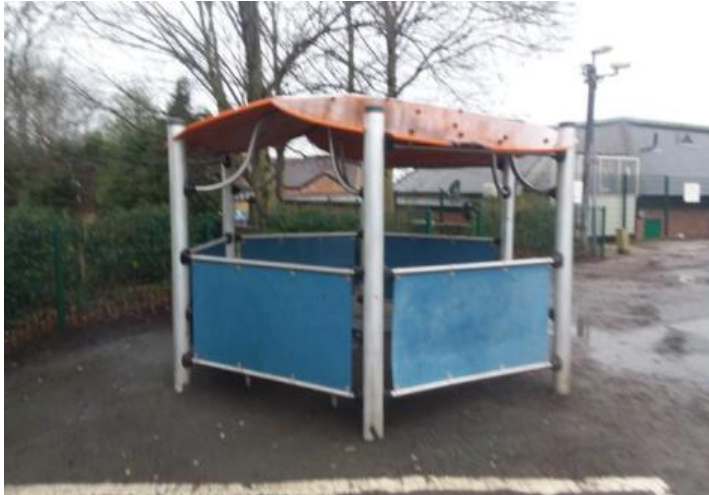
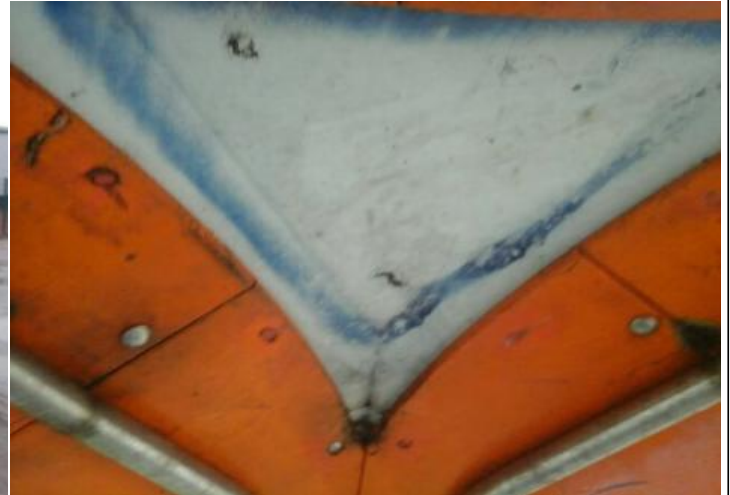
**Item:** Ancillary Items - Shelter  
**Manufacturer:** Proludic

**Finding:** There is some graffiti present

**Action:** Remove the graffiti

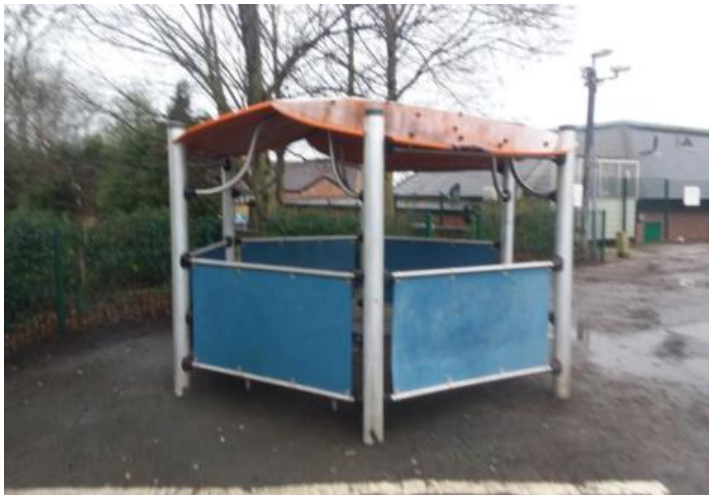
**Item:** Ancillary Items - Shelter  
**Manufacturer:** Proludic

**Finding:** There is minor damage to the seats **Action:** Monitor for any further damage and repair as required

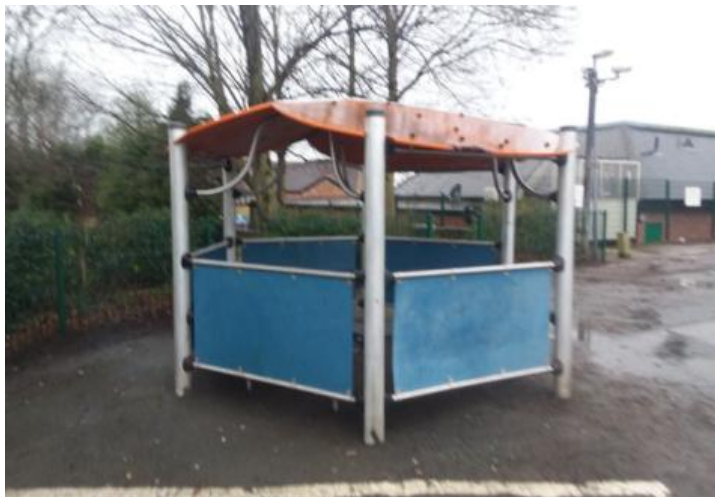
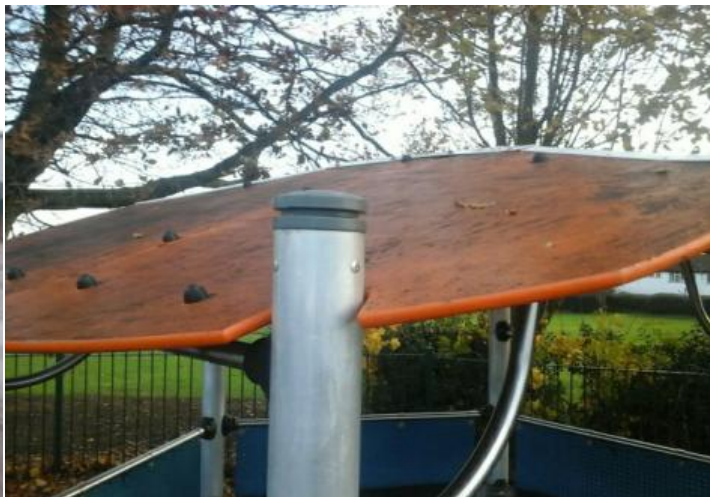
**Item:** Ancillary Items - Shelter  
**Manufacturer:** Proludic

**Finding:** Algae has formed on the roof surfaces

**Action:** Clean and treat as required

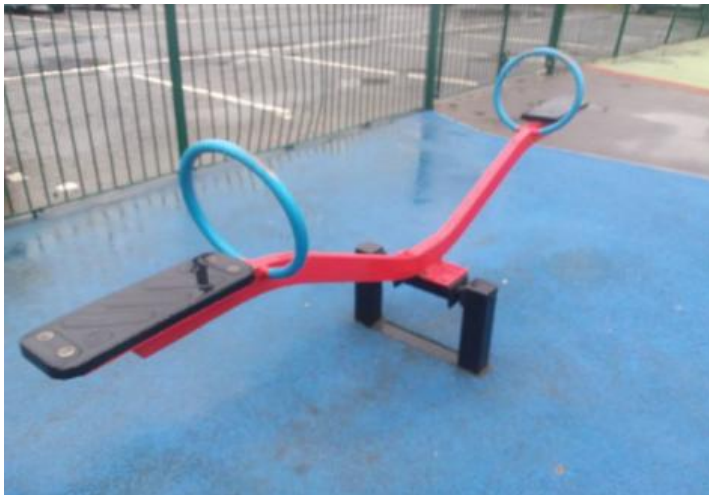
**Item:** Rocking Equipment - See Saw  
**Manufacturer:** Record RSS

**Finding:** The safety surface under the seats is beginning to wear

**Action:** Monitor for any further deterioration and repair as required

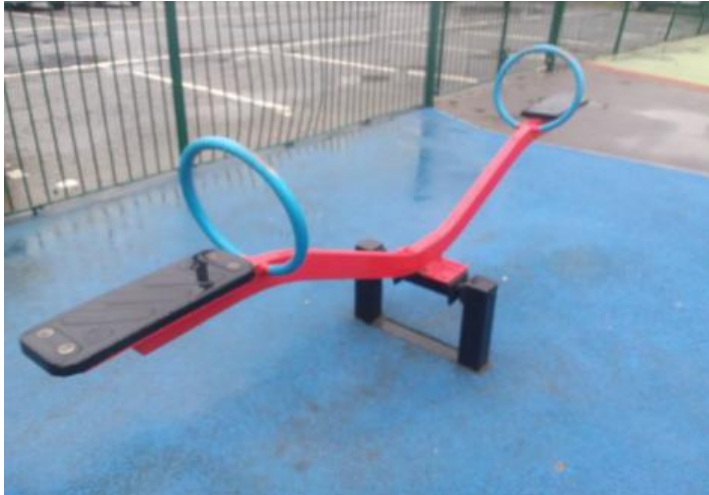
**Item:** Rocking Equipment - See Saw  
**Manufacturer:** Record RSS

**Finding:** The item is slightly loose in its foundations

**Action:** Monitor for any further deterioration and repair as required

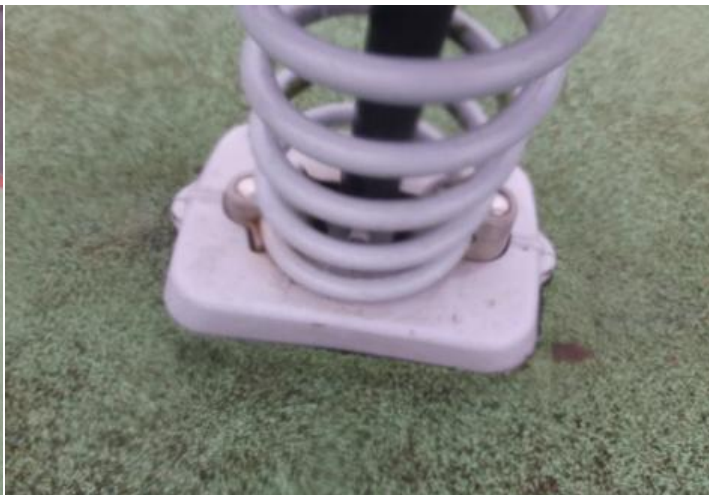
**Item:** Rocking Equipment - Spring See-Saw  
**Manufacturer:** Ledon

**Finding:** The U bolts clamping the spring are worn or loose

**Action:** Monitor for any further deterioration and replace or resecure as required

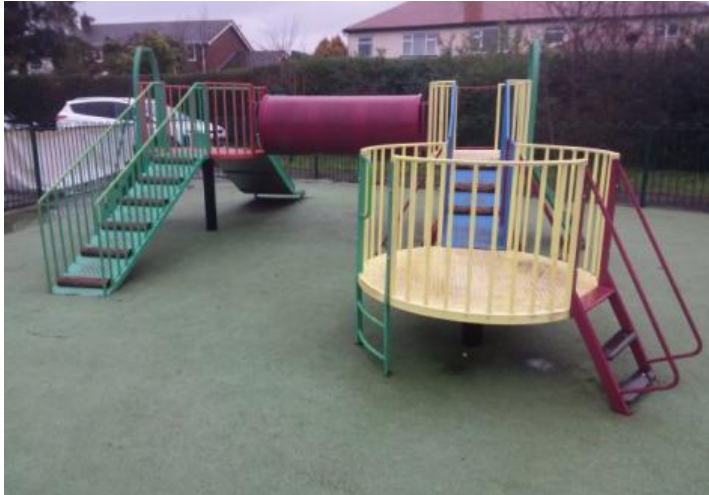
**Item:** Activity Equipment - Multi Play (Toddler)  
**Manufacturer:** Record RSS

**Finding:** The paintwork on this item has been damaged or worn exposing the metal underneath which is rusting

**Action:** Treat any rusting components and repaint

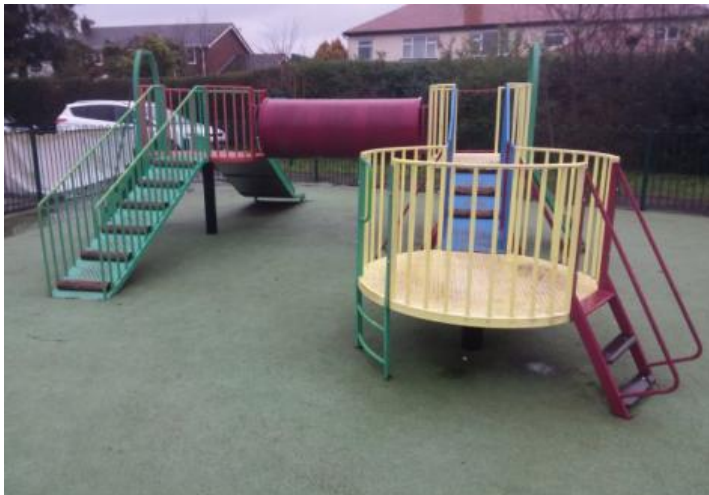
**Item:** Activity Equipment - Multi Play (Toddler)  
**Manufacturer:** Record RSS

**Finding:** There is some notable evidence of chain wear

**Action:** Monitor for any further deterioration and replace when 40% worn

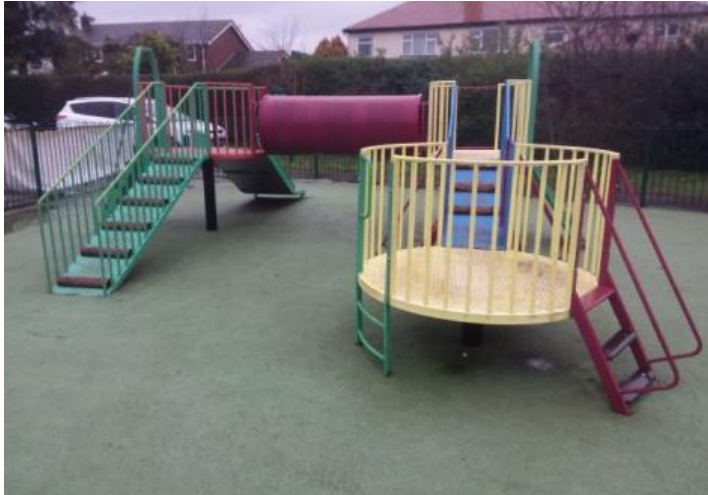
**Item:** Activity Equipment - Multi Play (Toddler)  
**Manufacturer:** Record RSS

**Finding:** A number of fixing(s) have worked loose

**Action:** Secure all loose fixings

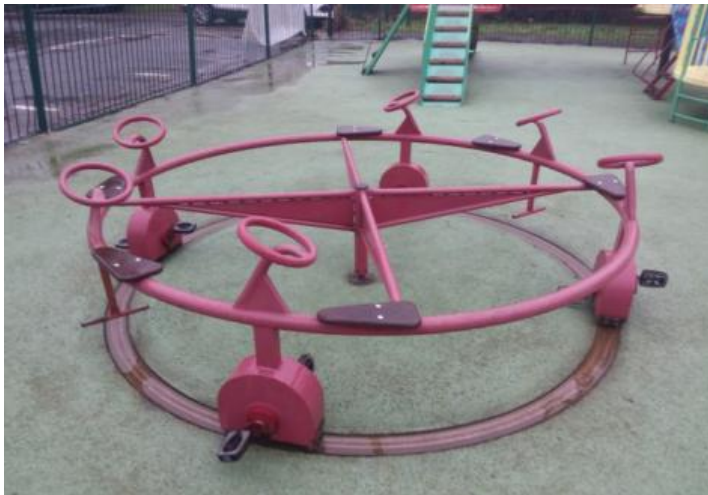
**Item:** Rotor Play - Pedal Roundabout  
**Manufacturer:** Hags

**Finding:** The pedals are missing from one of the cycles

**Action:** Replace the pedals as required

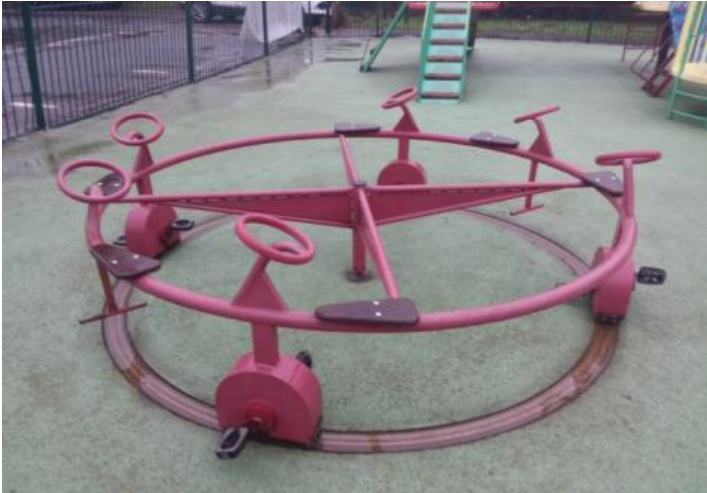
**Item:** Rotor Play - Pedal Roundabout  
**Manufacturer:** Hags

**Finding:** The item spindle is slightly loose in its foundations

**Action:** Monitor for any further deterioration and repair as required

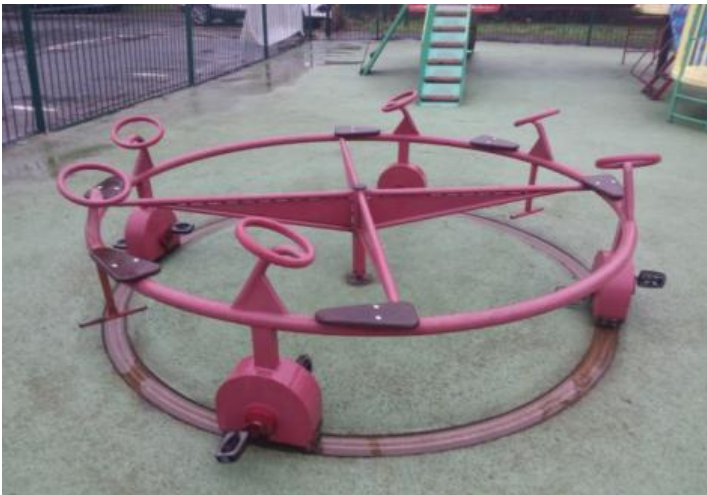
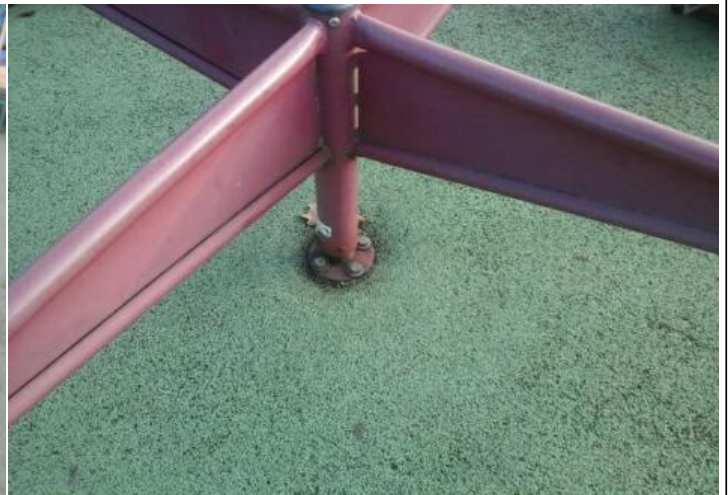
**Item:** Rotor Play - Pedal Roundabout  
**Manufacturer:** Hags

**Finding:** The bearing on the unit is dry

**Action:** Service and lubricate the bearing(s)

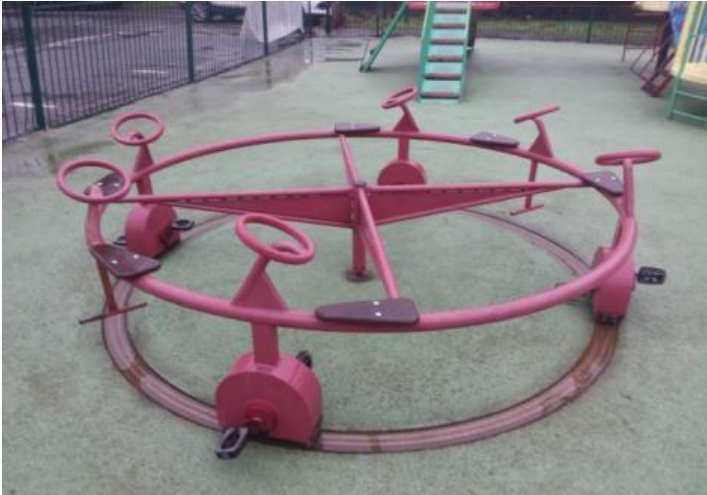
**Item:** Rotor Play - Pedal Roundabout  
**Manufacturer:** Hags

**Finding:** There is wear to the guards/covers

**Action:** Monitor for any further deterioration and repair as required.

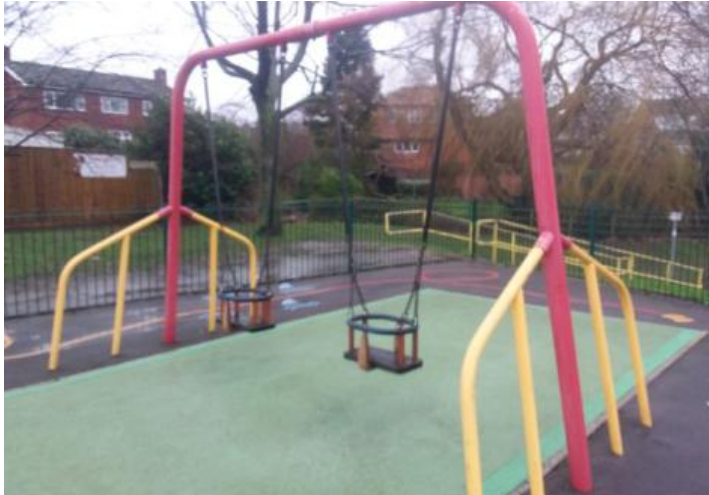
**Item:** Swings - 1 Bay 2 Seat (Cradle)  
**Manufacturer:** Record RSS

**Finding:** There is some chain wear

**Action:** Monitor for any further deterioration and replace when 40% worn

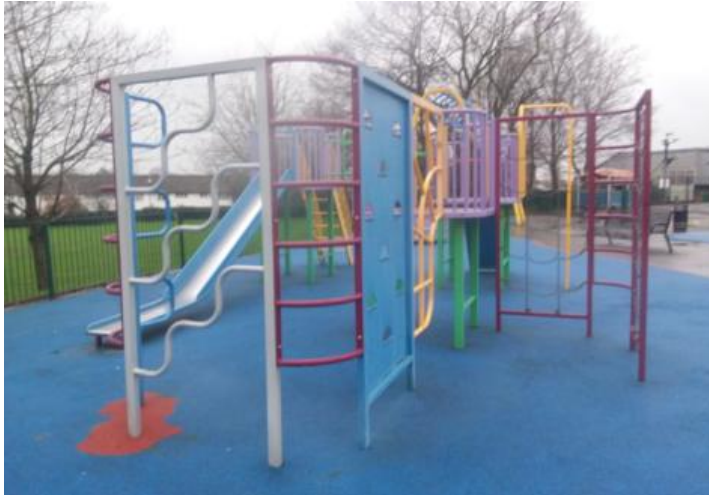
**Item:** Activity Equipment - Multi Play (Junior)  
**Manufacturer:** Record RSS

**Finding:** There is wear to the chain connecting lugs

**Action:** Monitor for any further wear and replace when 40 % worn

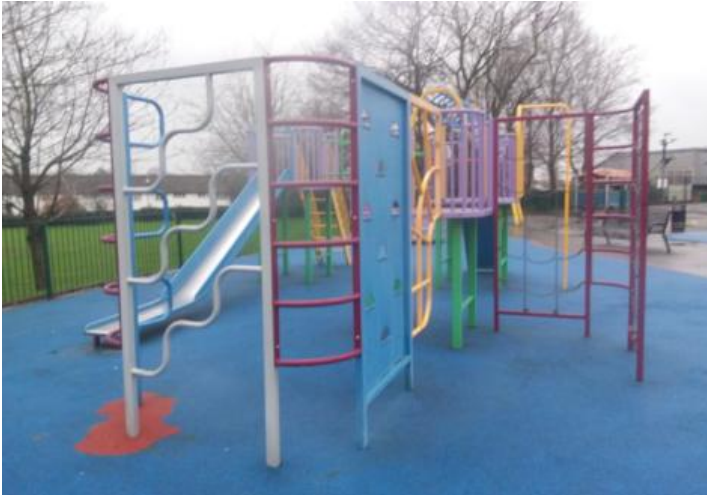
**Item:** Activity Equipment - Multi Play (Junior)  
**Manufacturer:** Record RSS

**Finding:** There are gaps opening between the surfacing and the edging surround or between the joints in the surfacing  
**Action:** Monitor for any further deterioration and repair as required

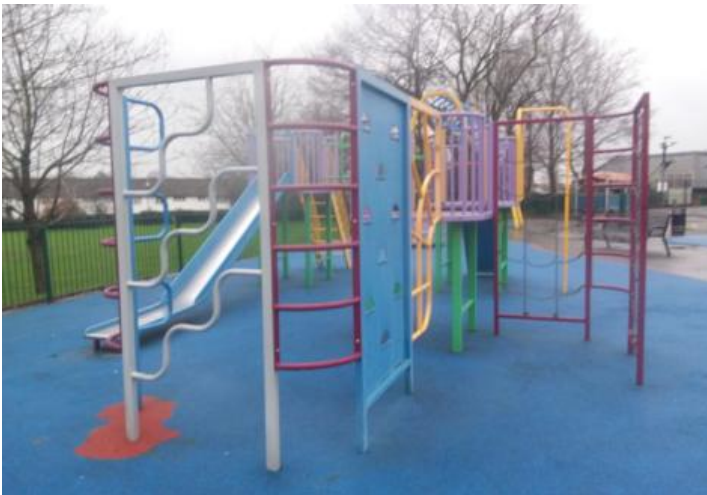
**Item:** Activity Equipment - Multi Play (Junior)  
**Manufacturer:** Record RSS

**Finding:** There are trip hazards at the edges of the surface  
**Action:** Reinstall surrounding surface levels to remove the trip points

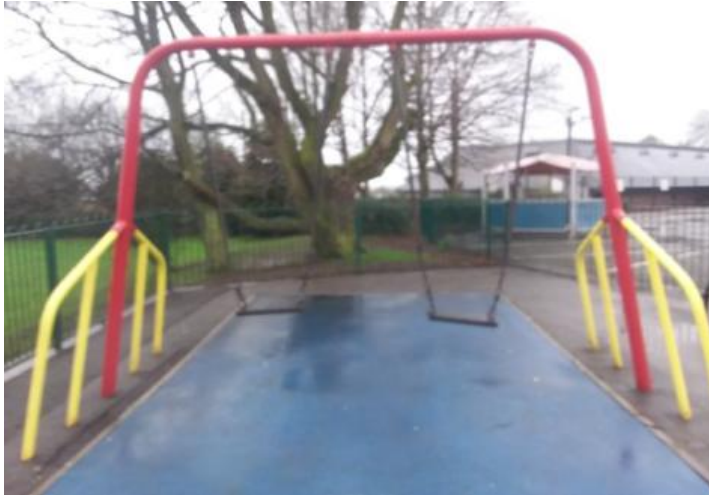
**Item:** Swings - 1 Bay 2 Seat (Flat)  
**Manufacturer:** Record RSS

**Finding:** The swing seat connectors are loose

**Action:** Tighten to secure

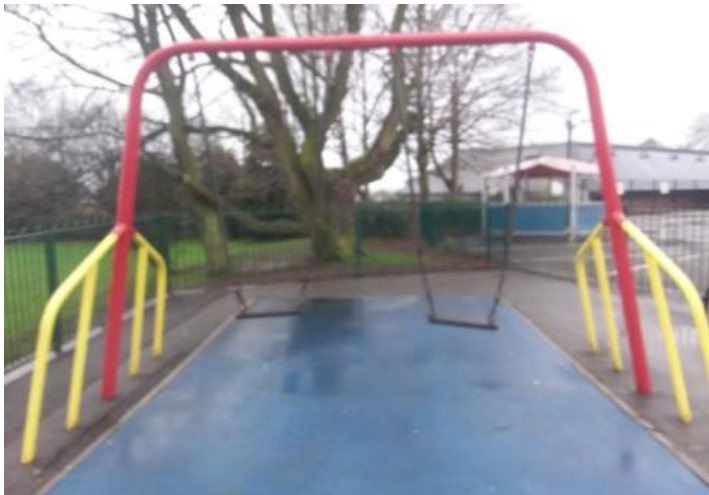
**Item:** Swings - 1 Bay 2 Seat (Flat)  
**Manufacturer:** Record RSS

**Finding:** There is some wear to the shackles.

**Action:** Monitor for any further deterioration and replace when 40% worn

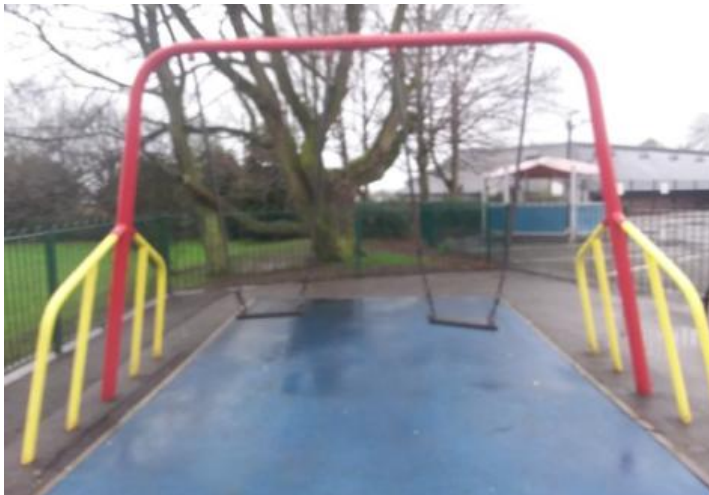
**Item:** Swings - 1 Bay 2 Seat (Flat)  
**Manufacturer:** Record RSS

**Finding:** The chain links are worn in excess of 40% and require renewing

**Action:** Replace worn chains

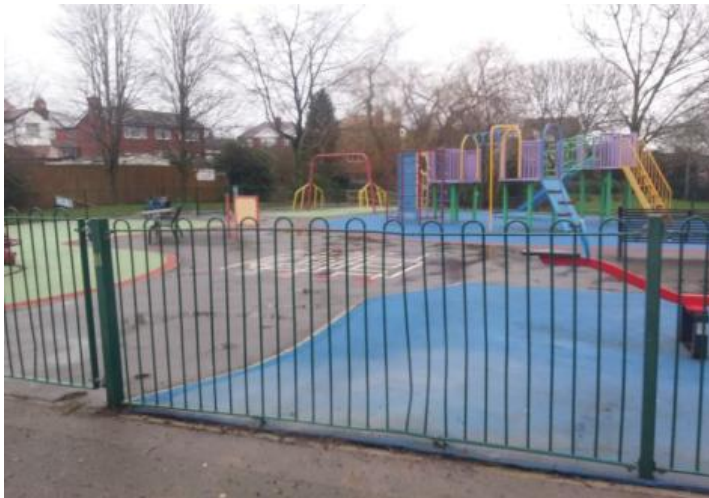
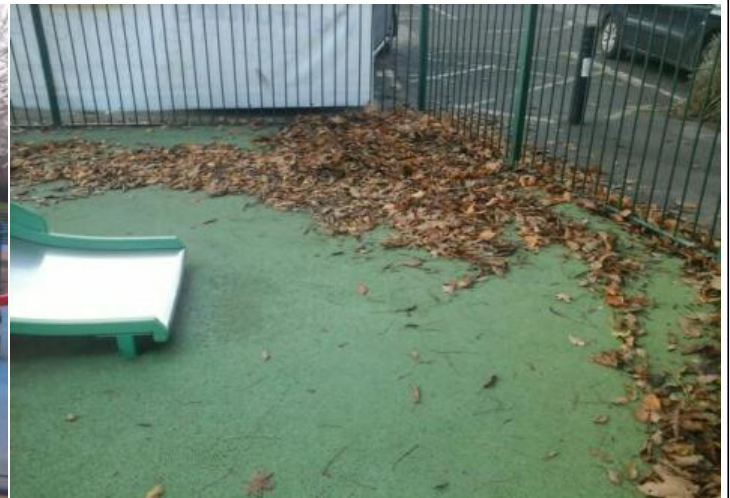
**Item:** Ancillary Items - Site General  
**Manufacturer:** Owner/Operator

**Finding:** There is some tree debris on the surfacing

**Action:** Remove and maintain

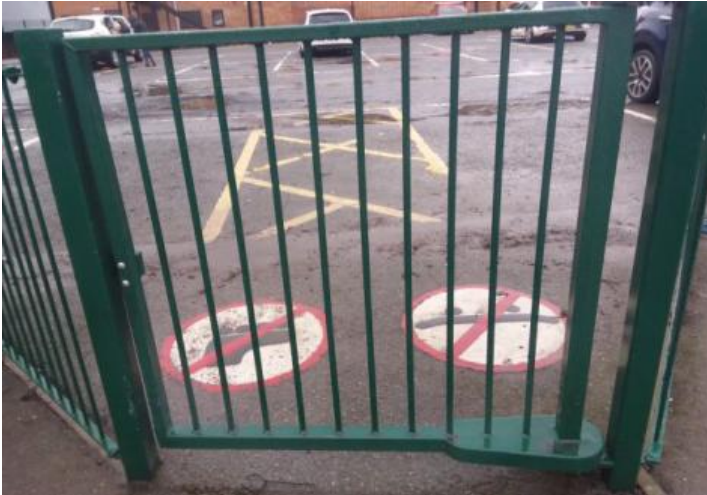
**Item:** Ancillary Items - Gate - Self Closing  
**Manufacturer:** Owner/Operator

**Finding:** The gate is not a contrasting colour to the fencing making it difficult for users with impaired sight to distinguish it from the fence

**Action:** We would recommend that the gates are painted a distinguishable colour to that of the fence

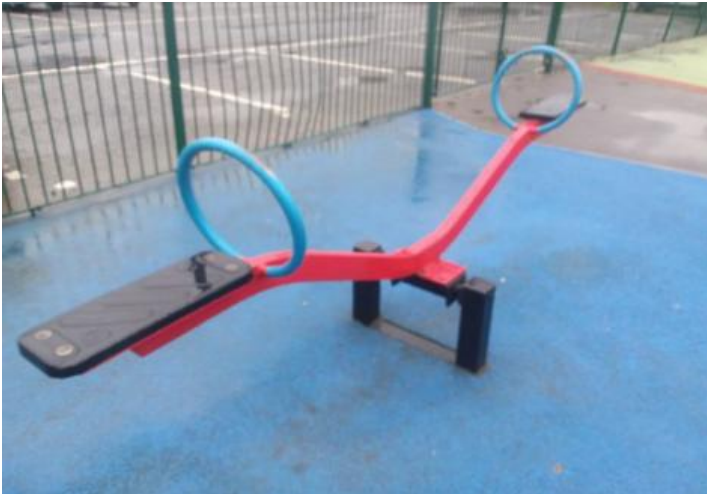
**Item:** Rocking Equipment - See Saw  
**Manufacturer:** Record RSS

**Finding:** The surface is lifting at the edges and creating trip points

**Action:** Repair perimeter of surfacing to remove trip points
